An assessment of the last seconds of the MH370

Argiris Kamoulakos

CAPTIO(N) Team Member

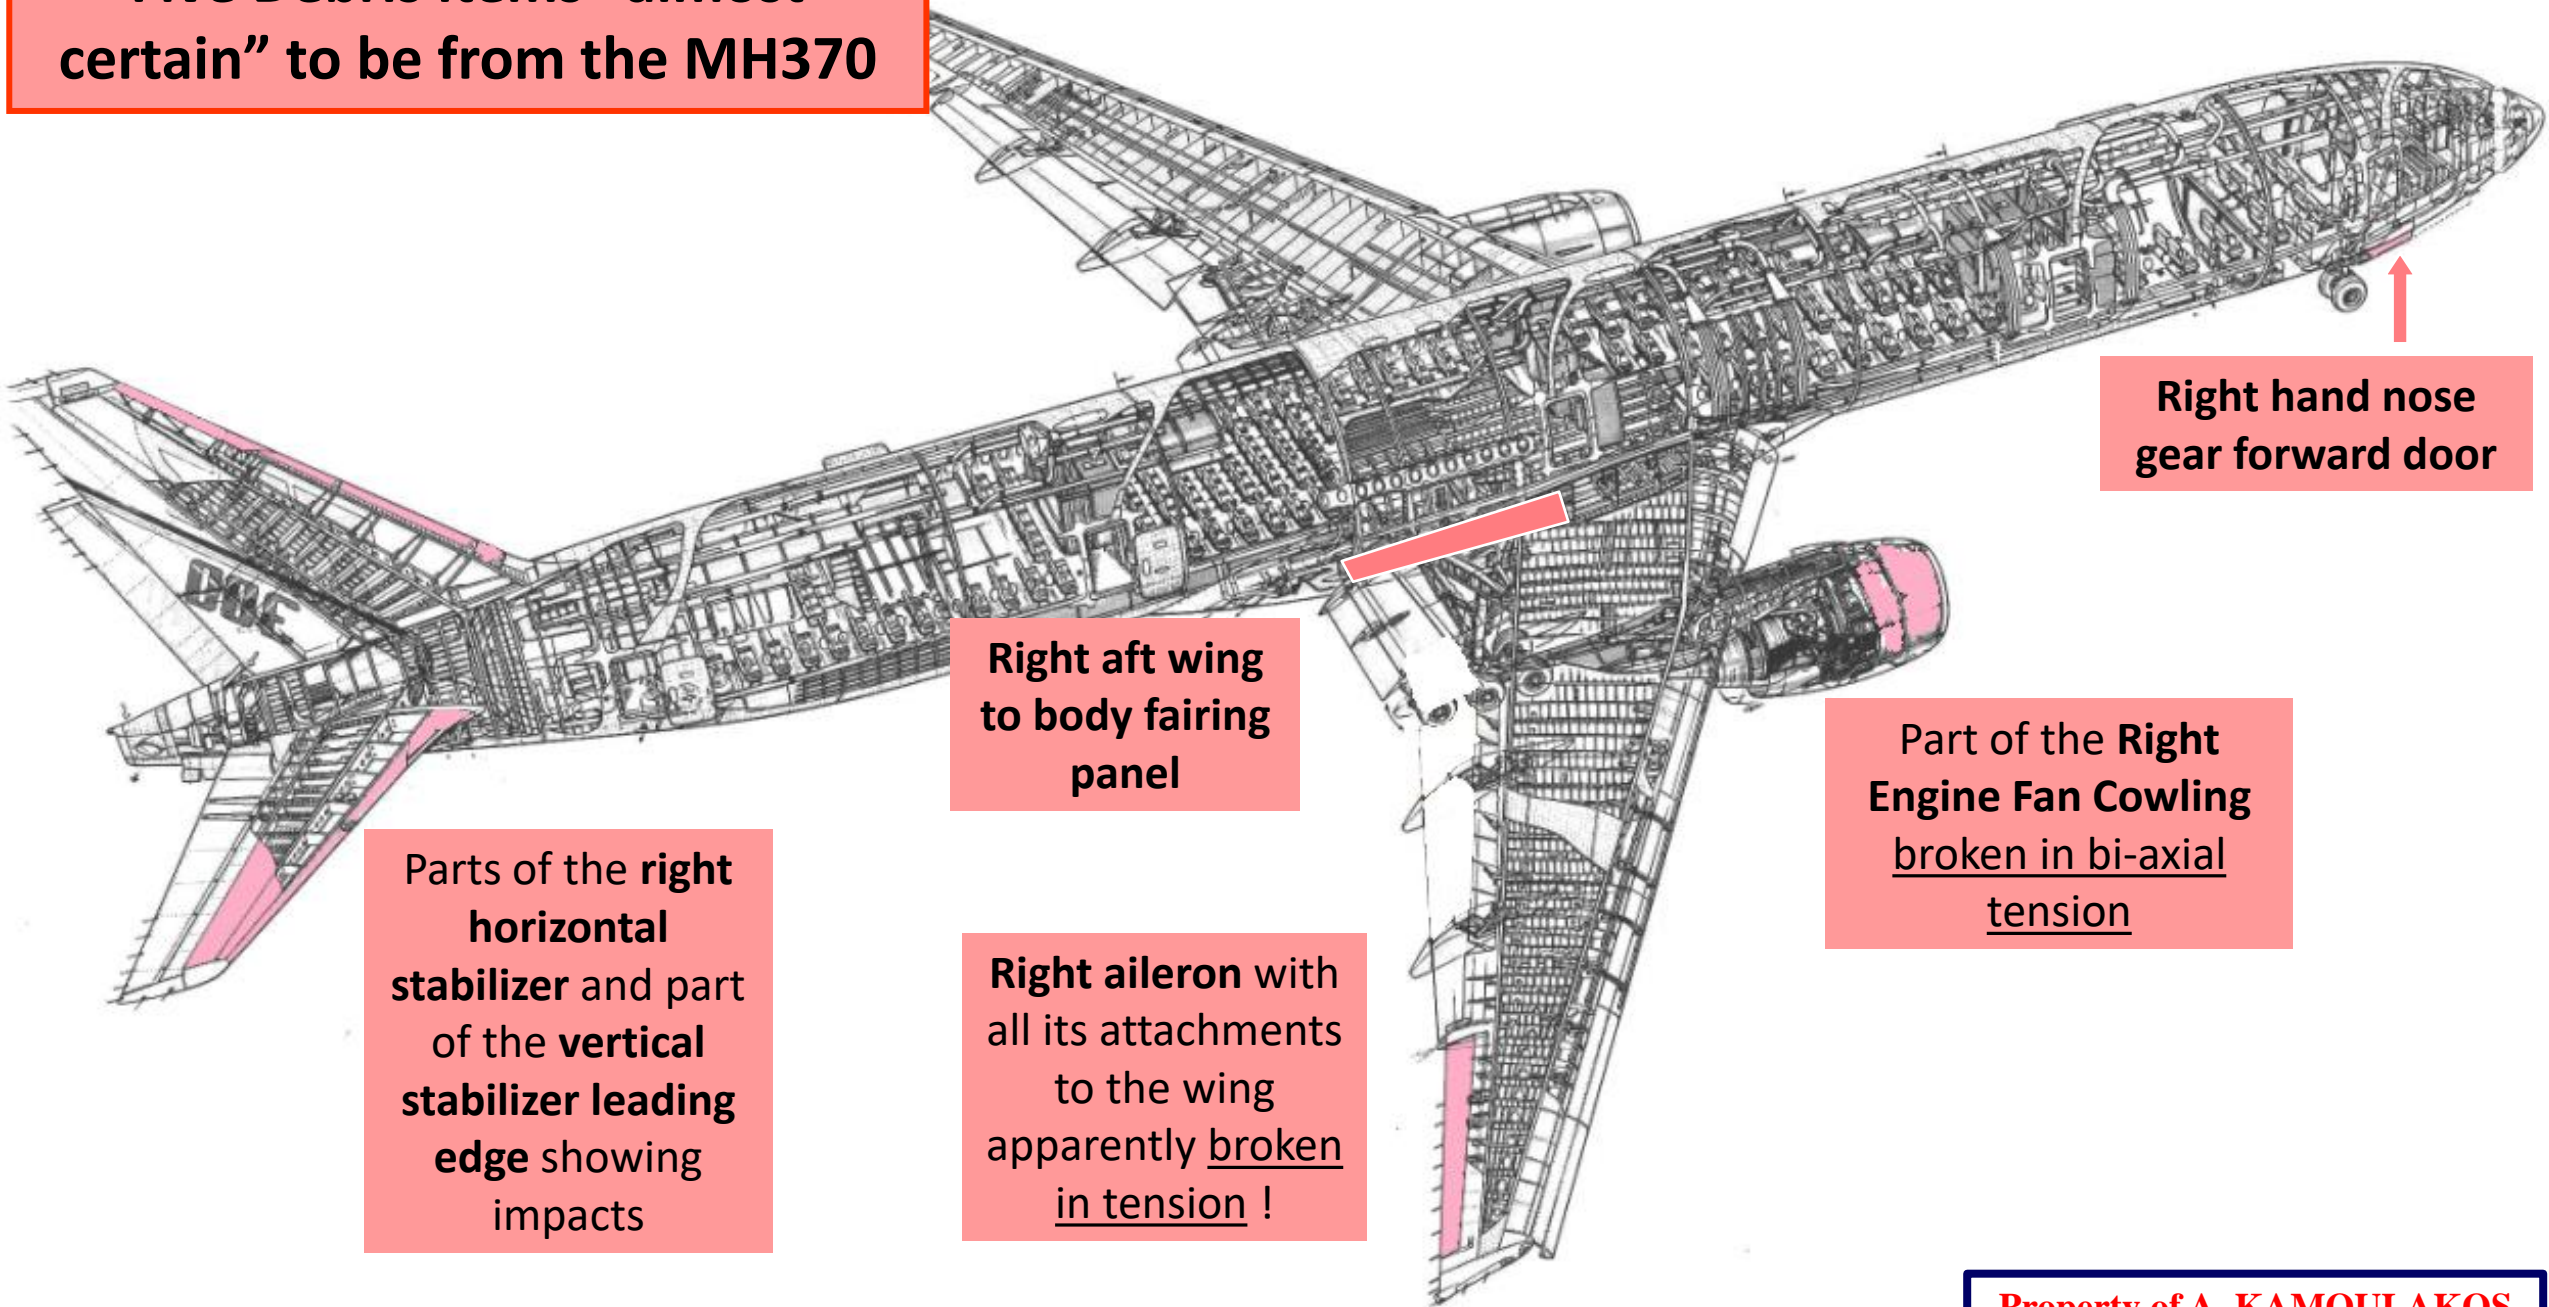
Five Debris items “almost certain” to be from the MH370

Right hand nose gear forward door

Right aft wing to body fairing panel

Parts of the right horizontal stabilizer and part of the vertical stabilizer leading edge showing impacts

Right aileron with all its attachments to the wing apparently broken in tension !

Part of the Right Engine Fan Cowling broken in bi-axial tension

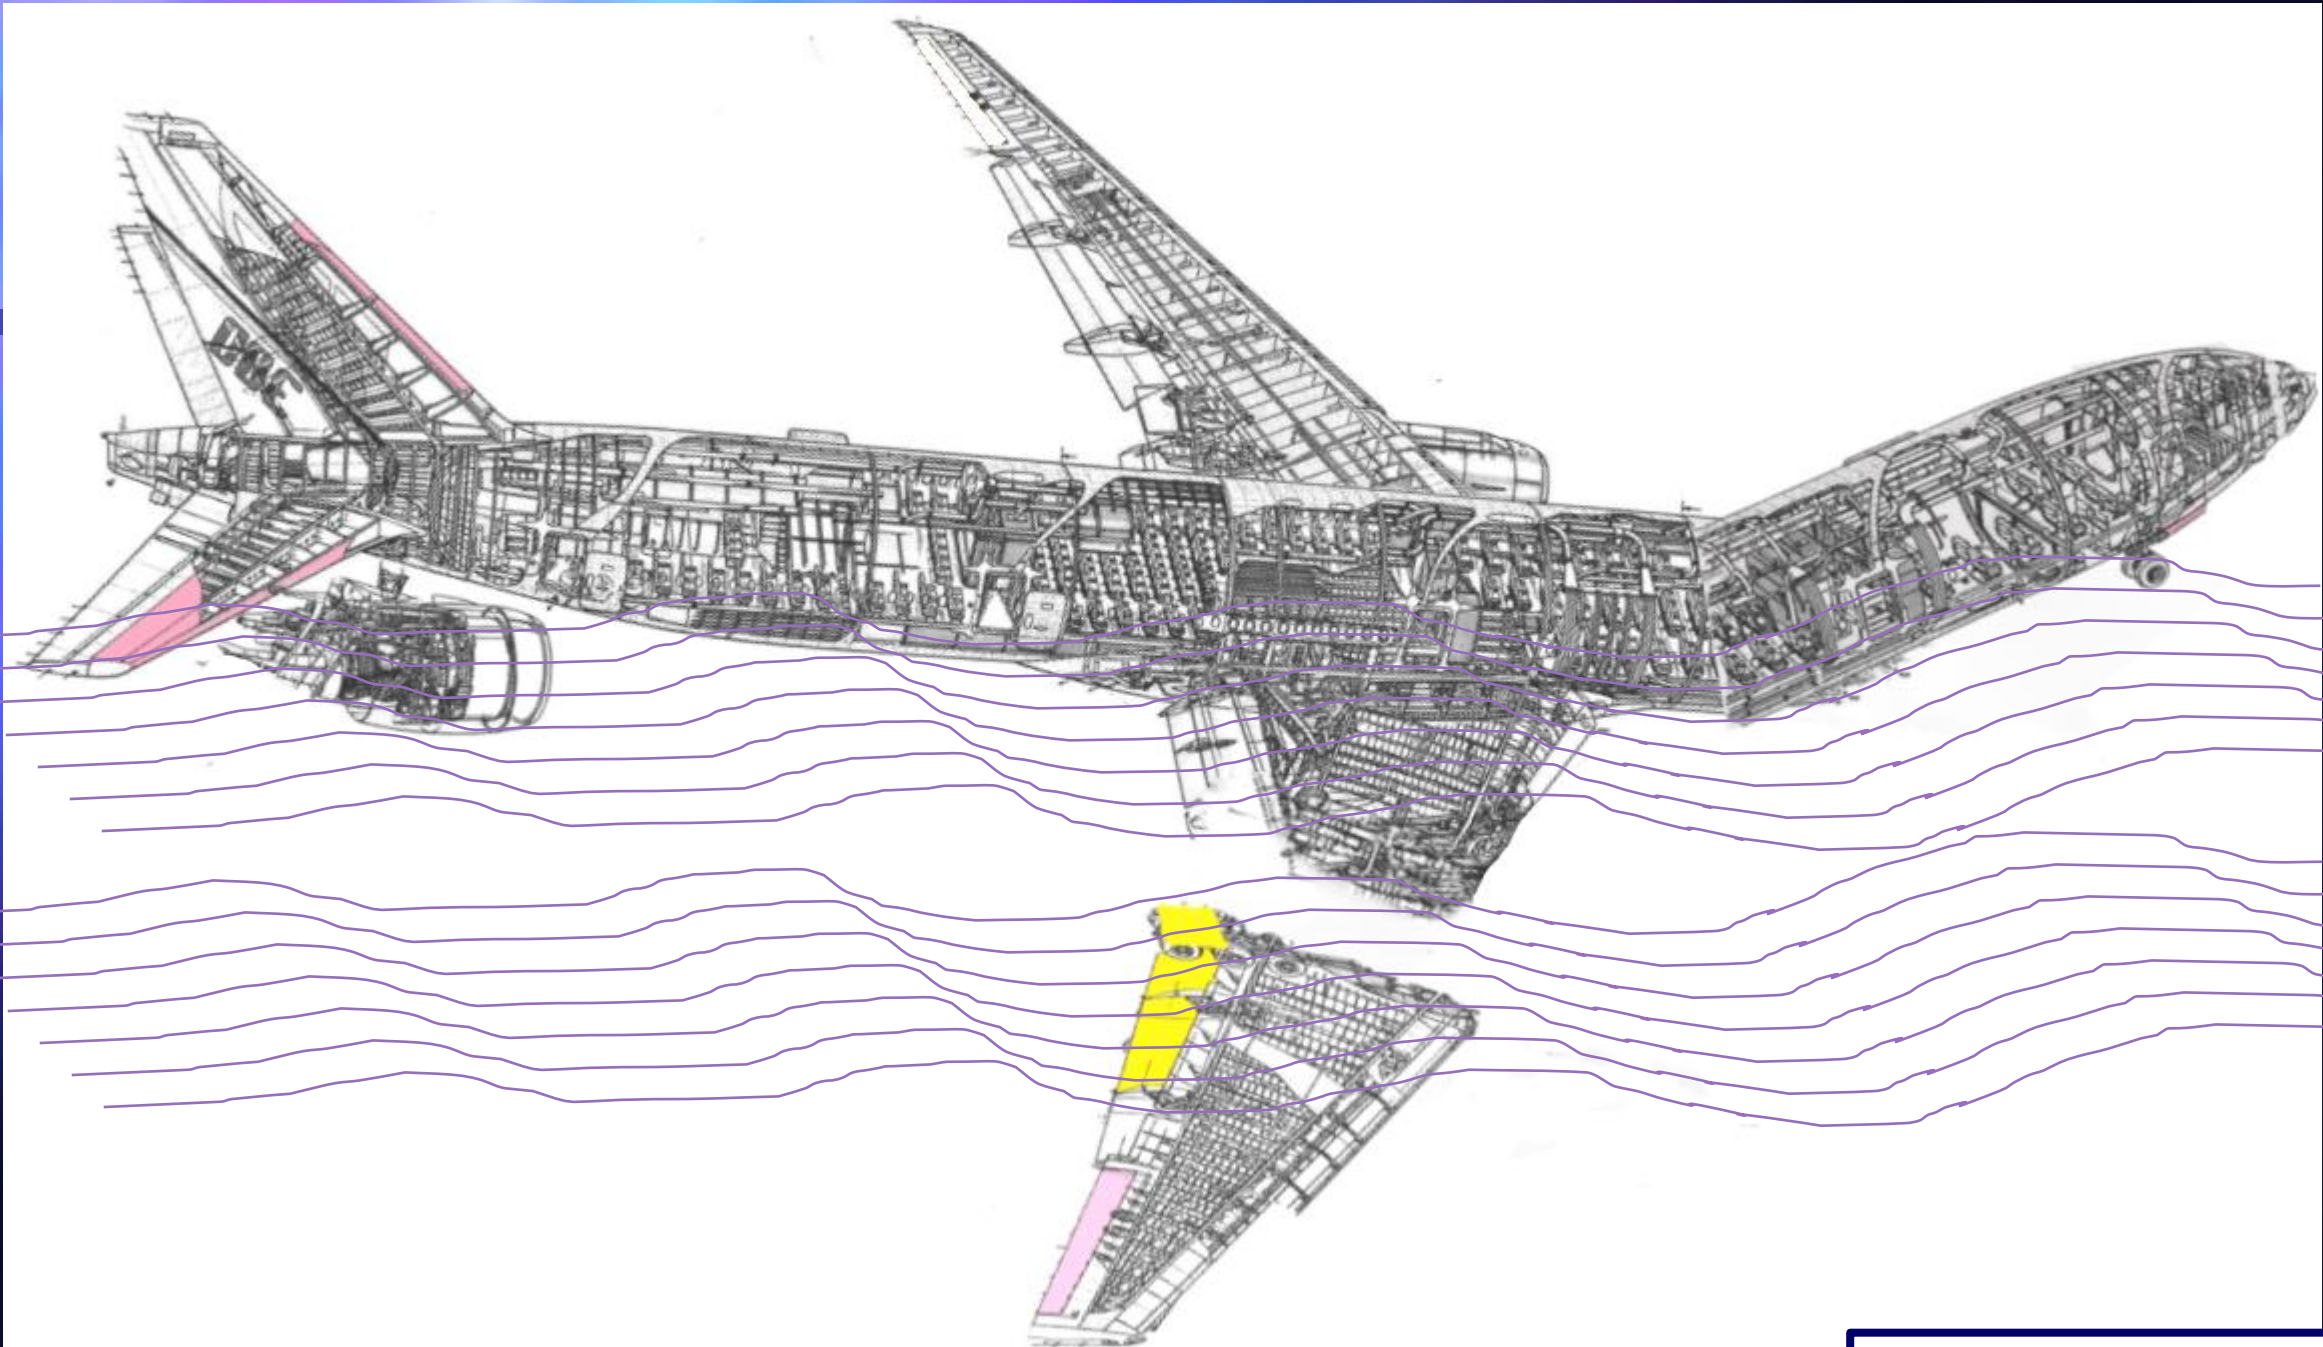
Release of the right engine

- **Release of the right engine from its supports** due to the large vertical and axial hydrodynamic loads.
 - Evidence from the cowling debris failure mode (bi-axial tension) that suggests internal hydrodynamic overpressure.
- Released engine and associated debris possibly moving backwards over the right wing and **impacting the right horizontal stabilizer and the vertical tail fin.**
- *Damage or eventual rupture of the rear part of the fuselage/cabin at the level behind the junction with the wing, but difficult to quantify.*

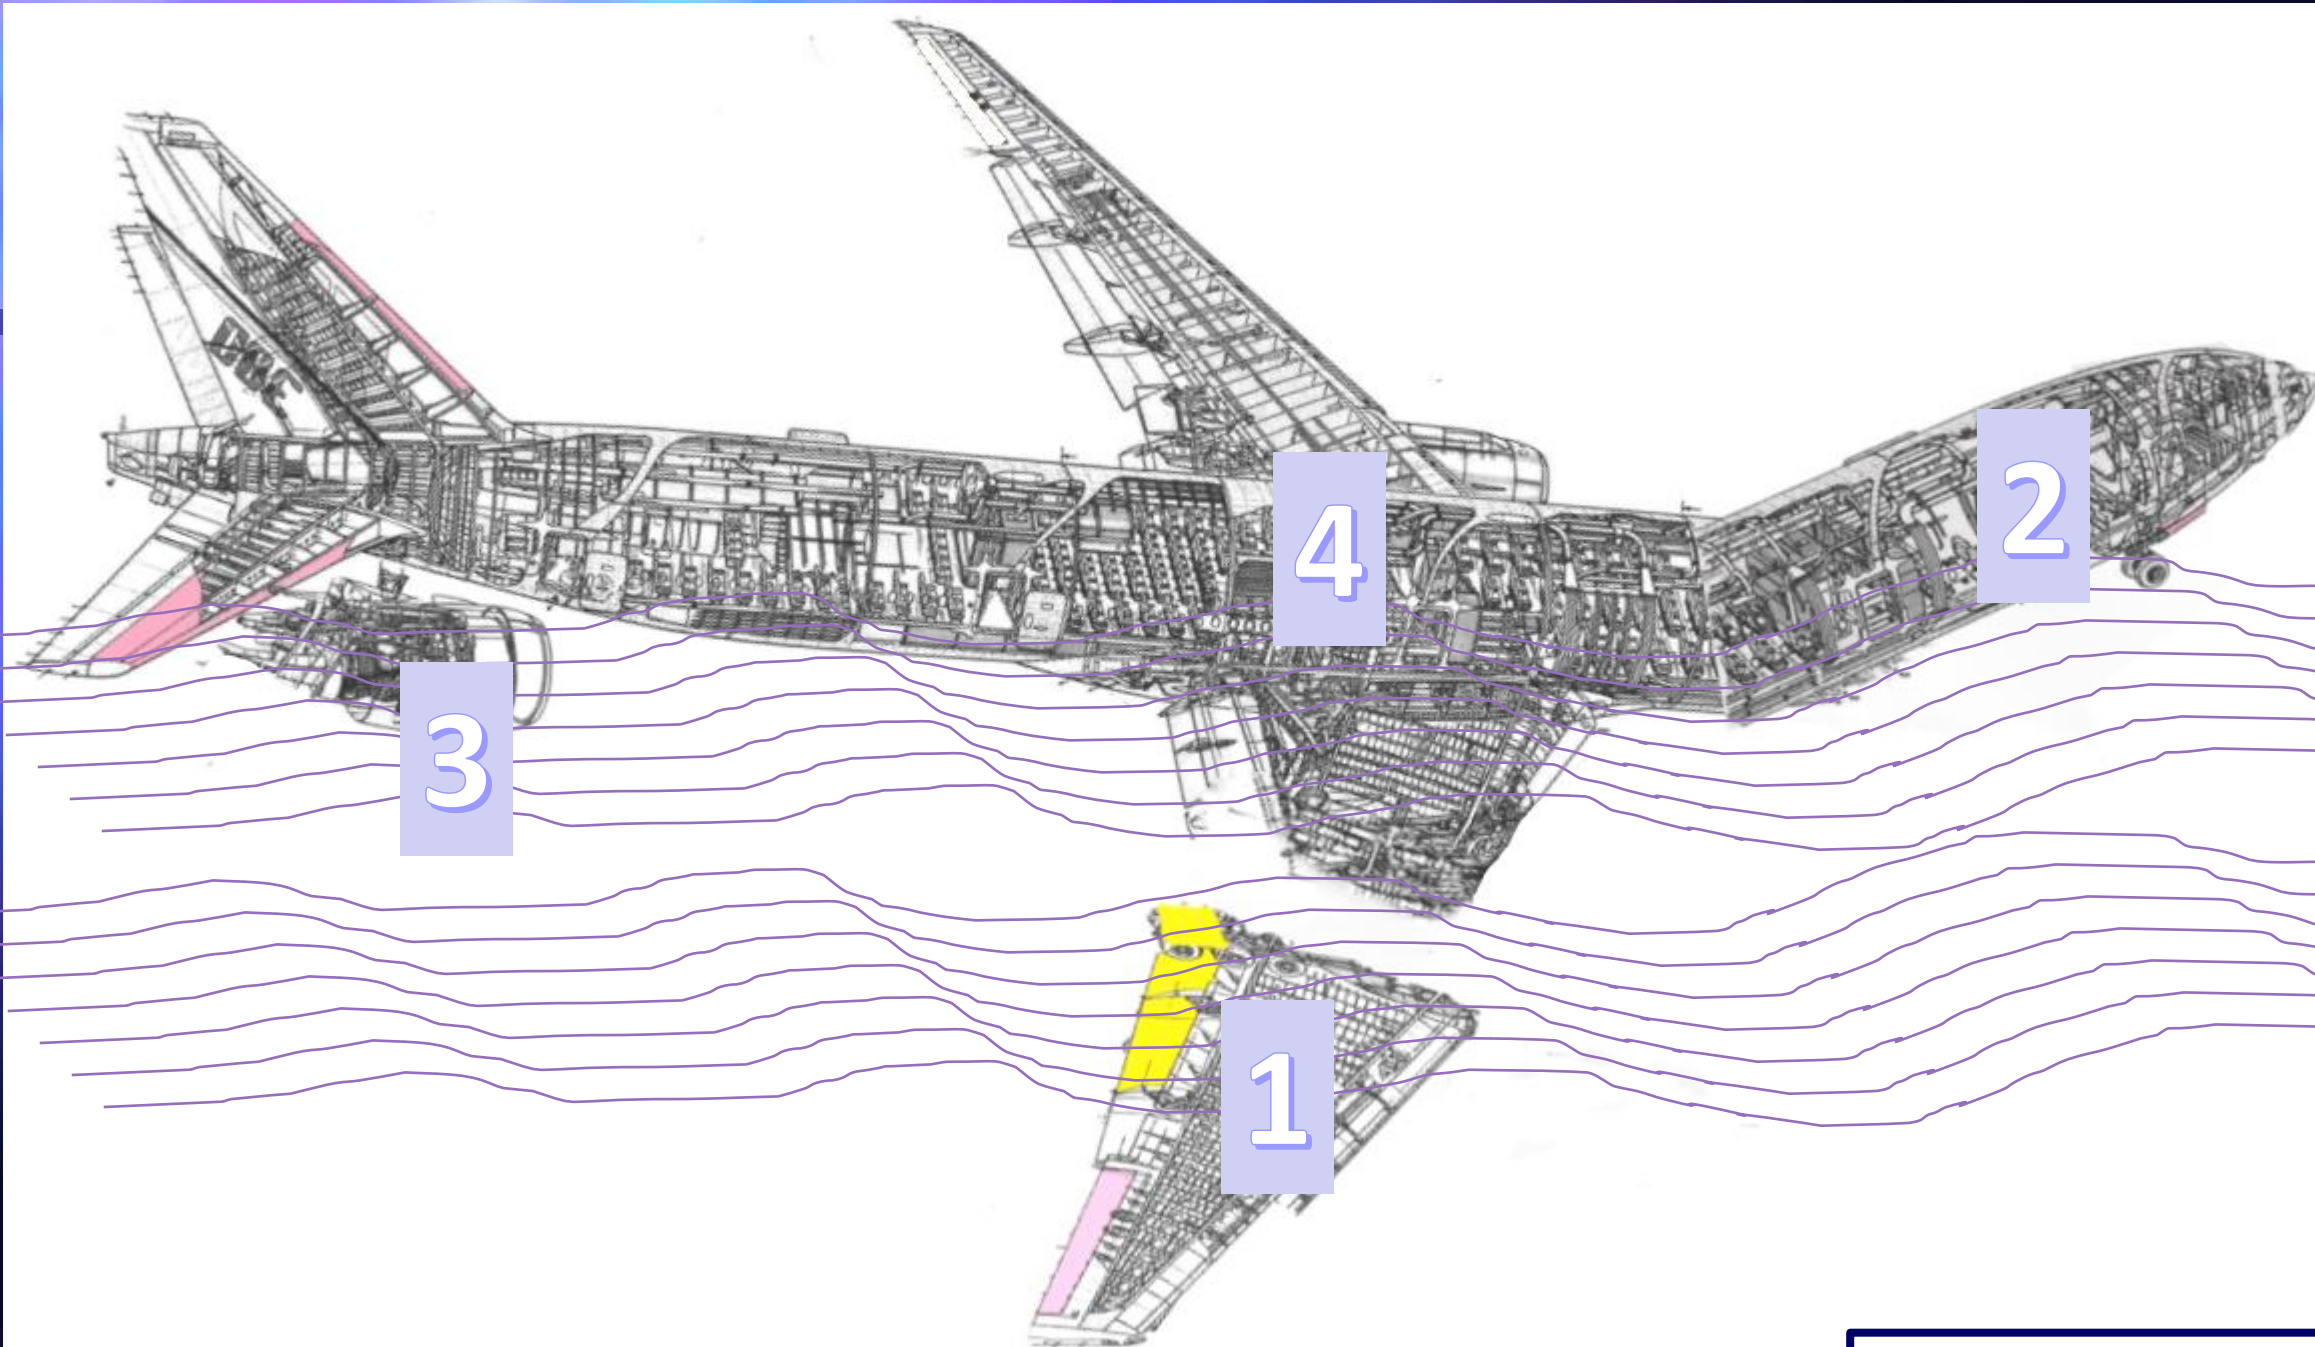
Aftermath ...

- Finally the **main aircraft wreckage** could consist of four parts:
 1. The right wing part from the engine pylon (Rib 25 area) outwards.
 2. The front part of the fuselage heavily damaged or detached.
 3. The right engine.
 4. The central fuselage with the root of the right wing and the entire left wing plus maybe the left engine and maybe the rear fuselage with the tailfin and right stabilizer heavily damaged, all as one piece.

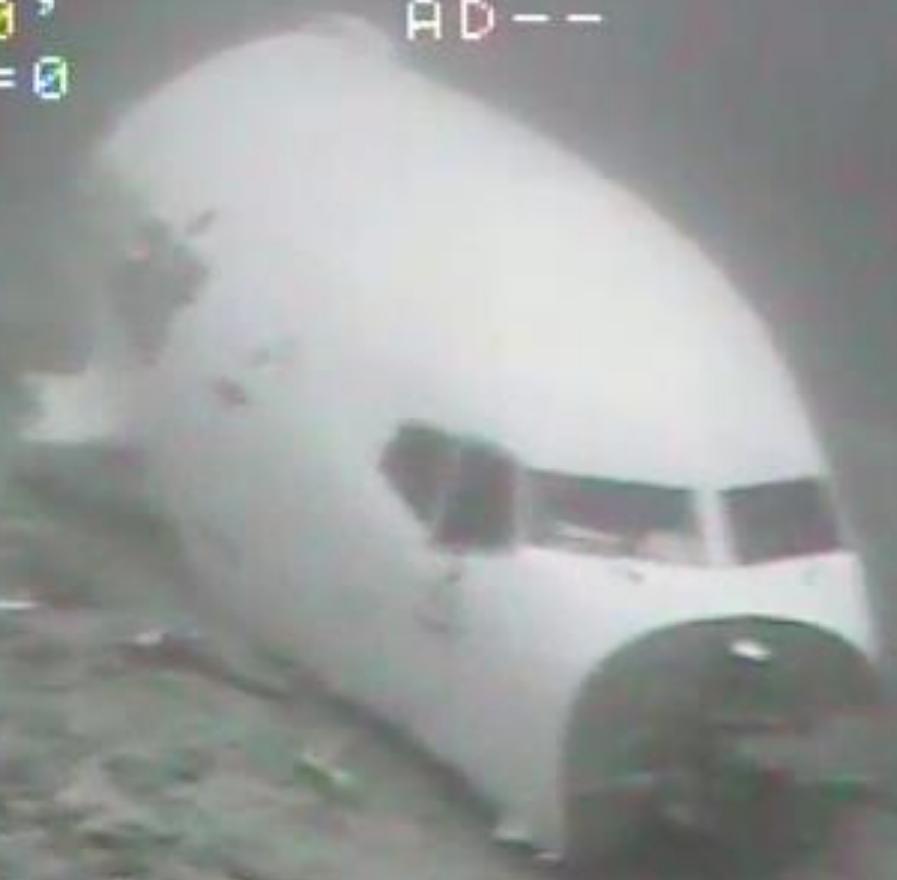
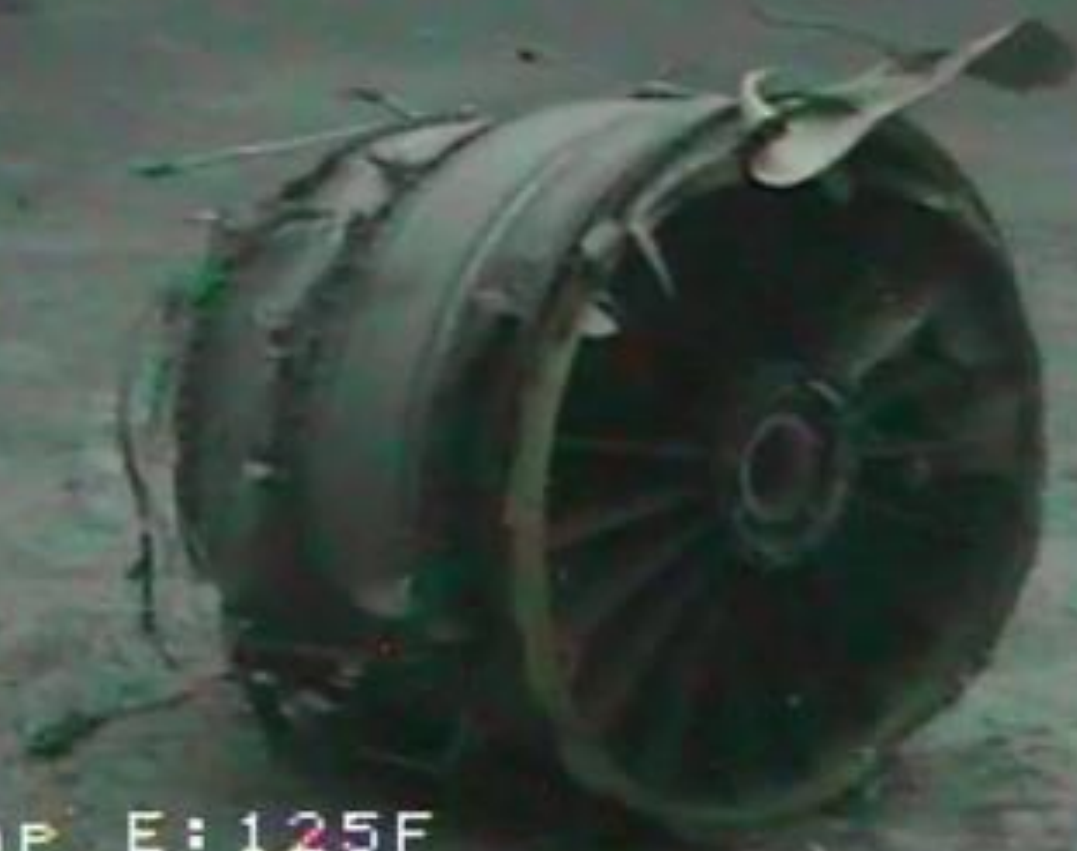
Aircraft broken in 3 parts

Transair Flight 810 was found approximately 2 miles offshore from Ewa Beach. **The major components of the airplane -- the aft fuselage including both wings and tail along with both engines, and forward fuselage -- were located on the sea floor at depths between 360 and 420 feet, the NTSB said in a statement.**
