# Debris Analysis

## Article recovered at Jeffreys Bay, SA.

Mike Exner and Don Thompson

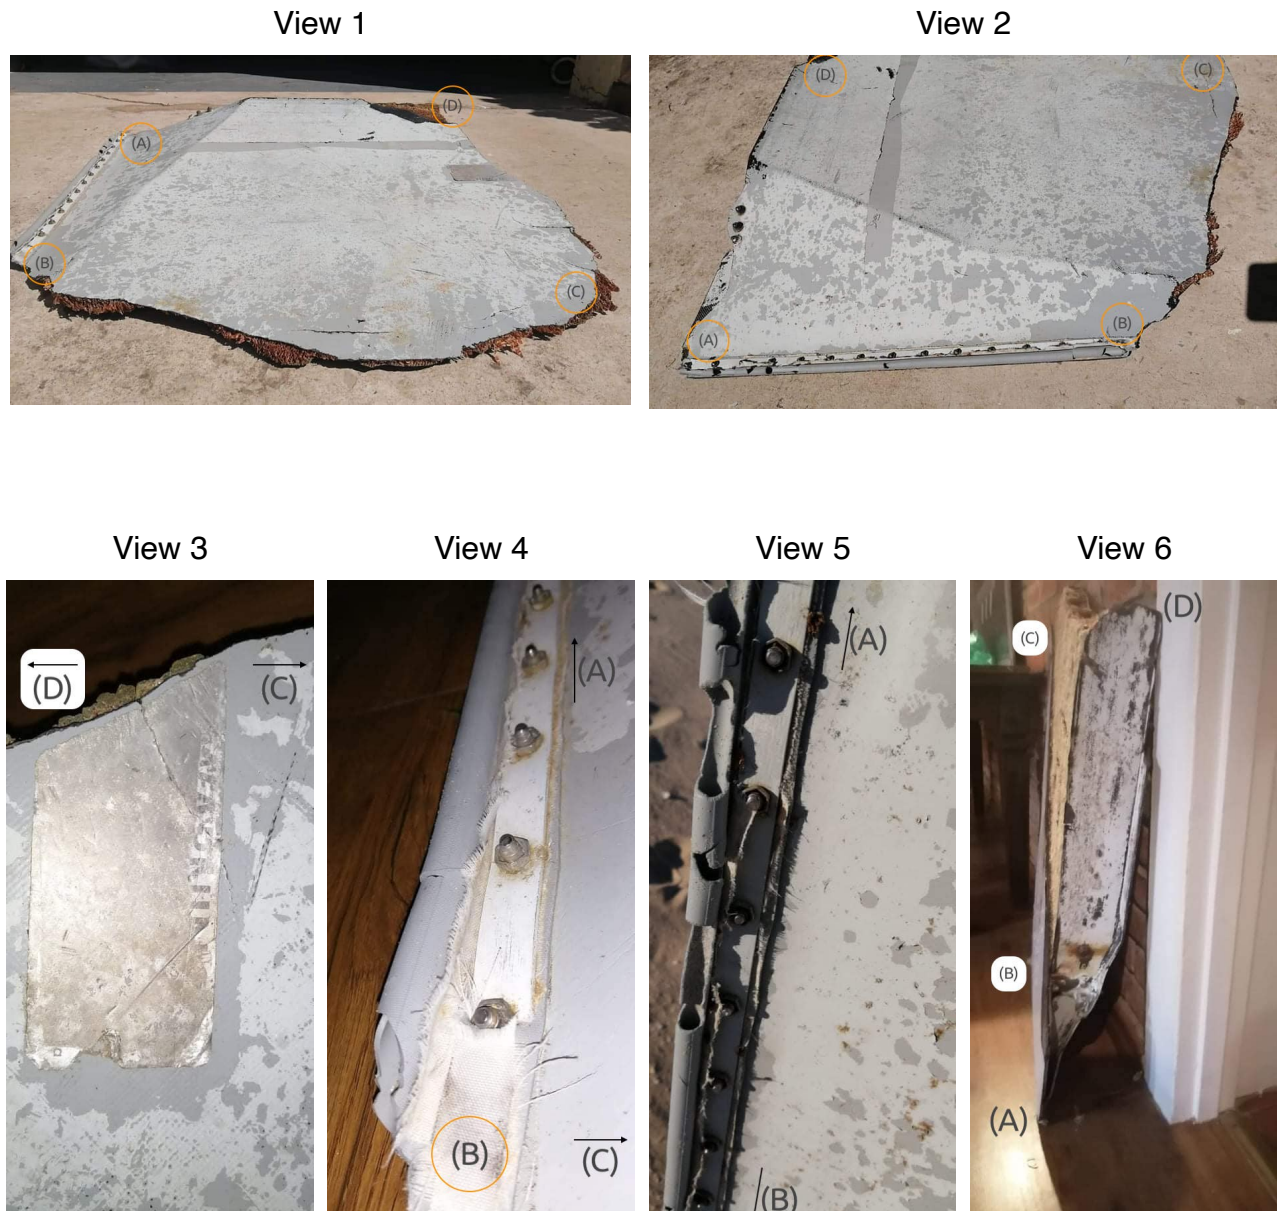
Figure 2: Debris Article General Views

The views of the debris item show a monolithic composite panel, constructed of CFRP skin and Nomex honeycomb core. CFRP skin plus Nomex honeycomb core

material is consistent with the design and manufacture of a modern aero-structure component. Less common use of these materials and construction technique on airframes designed prior to 1990 suggests that the article may originate from a B777.

The face that is predominantly featured in the views 1 through 5 is contoured with a geometric profile while the opposite face is flat (to left, view 6).

A remnant of an information placard remains on contoured surface (view 3).

The edge annotated as (A)-(B) is fitted with a 'P' section extrusion that is held in place under a retaining strip and fixed by HiLok machine screws. Remnant of a fabric material is evident under the retaining strip.

Fourteen screws fix the 'P' section extrusion in place. The (A) - (B) edge is not complete.

The edge (A)-(D) is formed as a face with a remnant part of a metallic fitting close to corner (A). Fixing screws for this fitting are apparent on the (A)-(D) face with three anchored through the edge of the contoured surface.

The images provided include no explicit dimensional reference. However, the adjacent doorway architrave and brick courses, evident in view 6, permit an estimate to be made for the article width, (A)-(D), and maximum depth at the face (A)-(D). Assuming a wall's course of standard brick size is 80mm:

Width (A)-(D): estimate 880mm.

Depth, face (A)-(D): estimate 160mm.

The face on edge (A)-(D) appears to present a surface for the article fixture. Edges (A)-(B) and (B)-(C) are unfixed, formed as seams of the upper and lower surfaces. Edge (C)-(D) is a full depth fracture through the article. An additional view illustrates the upper surface.

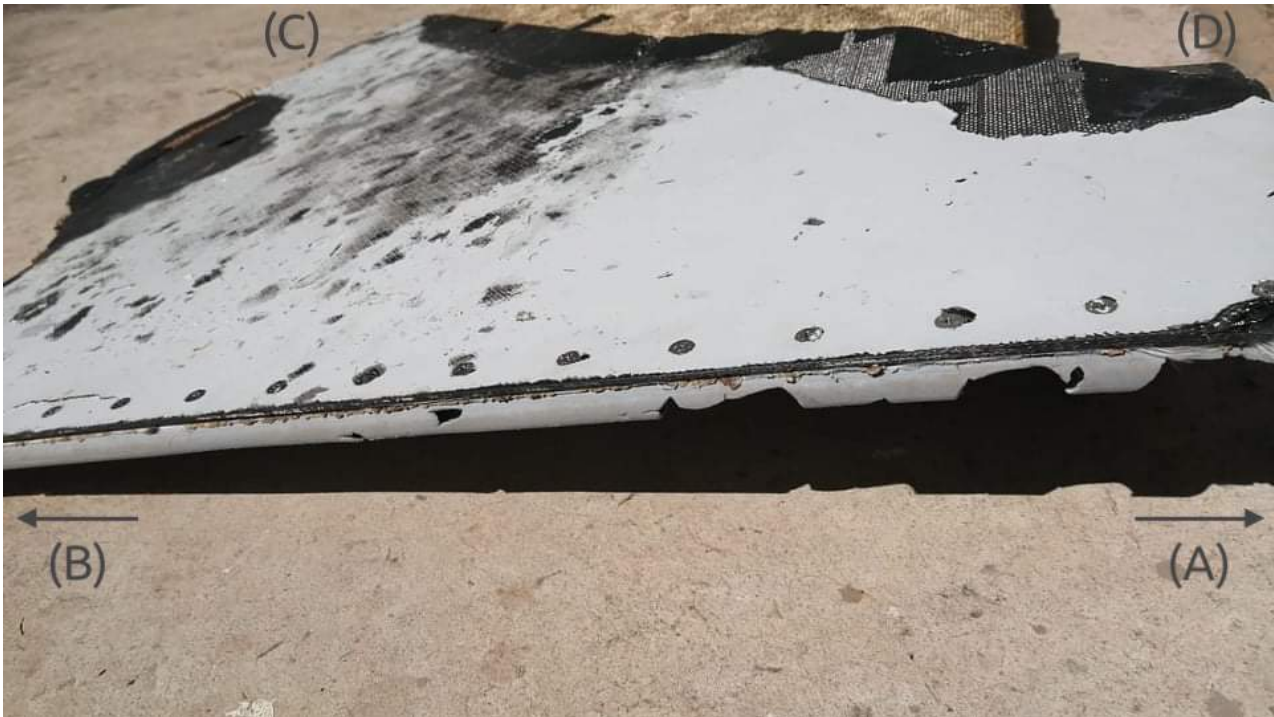
Figure 3: Recovered Debris Article. Upper Surface

The remnant of the information placard displays the upper half of characters spelling the word 'WARNING'. The placard is affixed to be read when the article is oriented with edge (A)-(D) down and edge (B)-(C) up, suggesting that the piece is normally fixed in the vertical plane or is capable of translating to a vertical position. This placard is an important discriminator for the identity of the article.

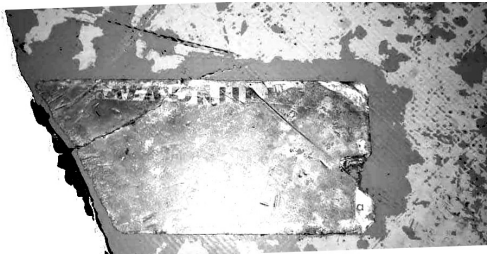
Placard as found, per view 3

This placard text refers to ATA Chapter 27-61-00, that is ‘Spoiler and Speed-brake Control’.

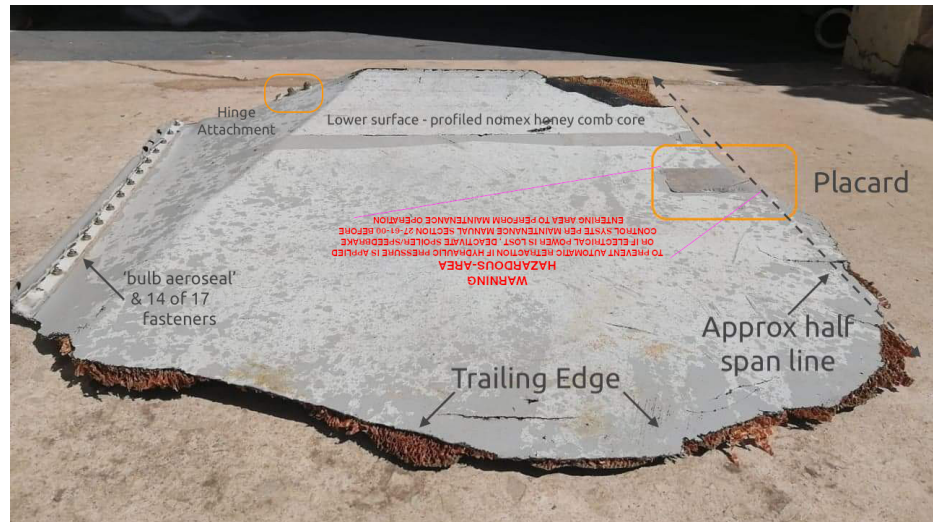
Figure 7: Recovered Article, Salient Features

- P-extrusion, fourteen fixing screws remaining
- Foot of hinge plate
- Warning placard

The warning placard, the absence of the deep actuator fixing recess extending aft across the lower face, and the fixing arrangement of the 'P'-extrusion aerofoil seal are firm indicators that the article is a B777 inboard spoiler.

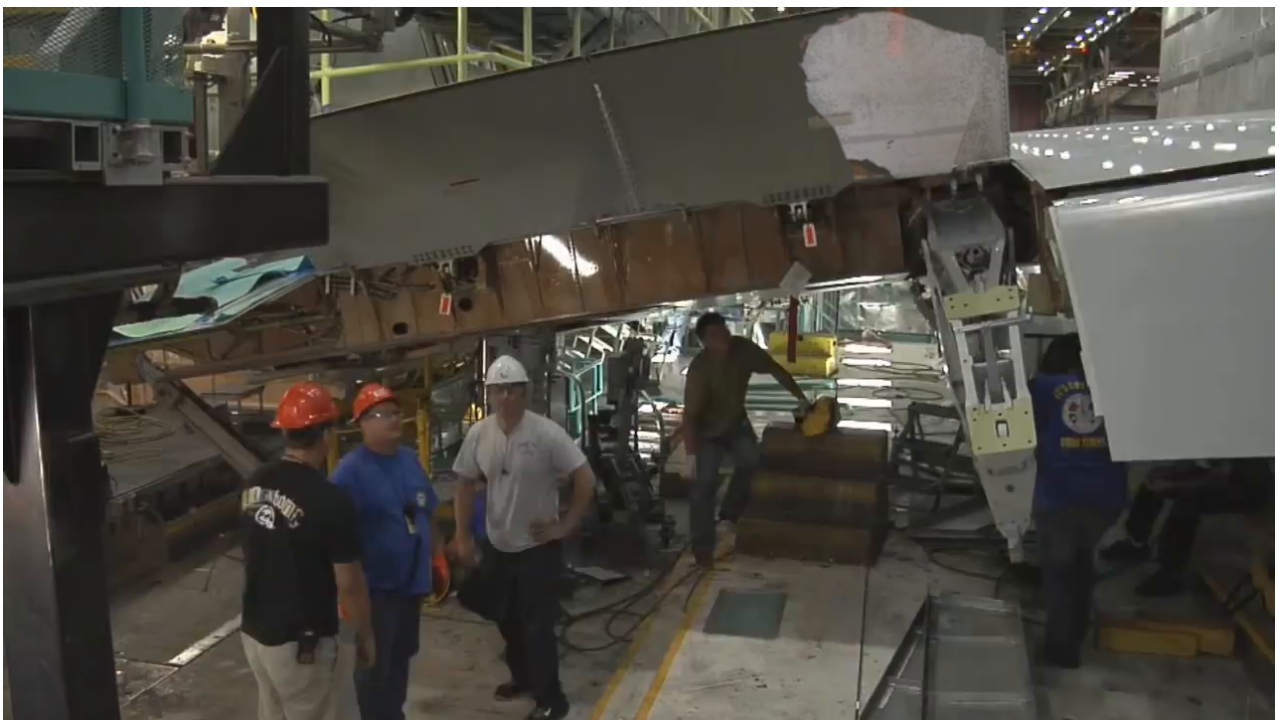
Recovered article overlay on spoiler #9  
(note: at the time of writing there is insufficient detail to match article to #8 or #9)

Dimensions, estimated for recovered article: span, 880mm.

Adding to the previously stated identifying characteristics, the dimension of recovered article corresponds with an inboard spoiler originating from the right wing, spoiler #8 or #9.

However, with only the photographic images at hand, it is not possible to discriminate the recovered article as either spoiler #8 or #9.
