An assessment of the last seconds of the MH370

Argiris Kamoulakos

08 March 2024

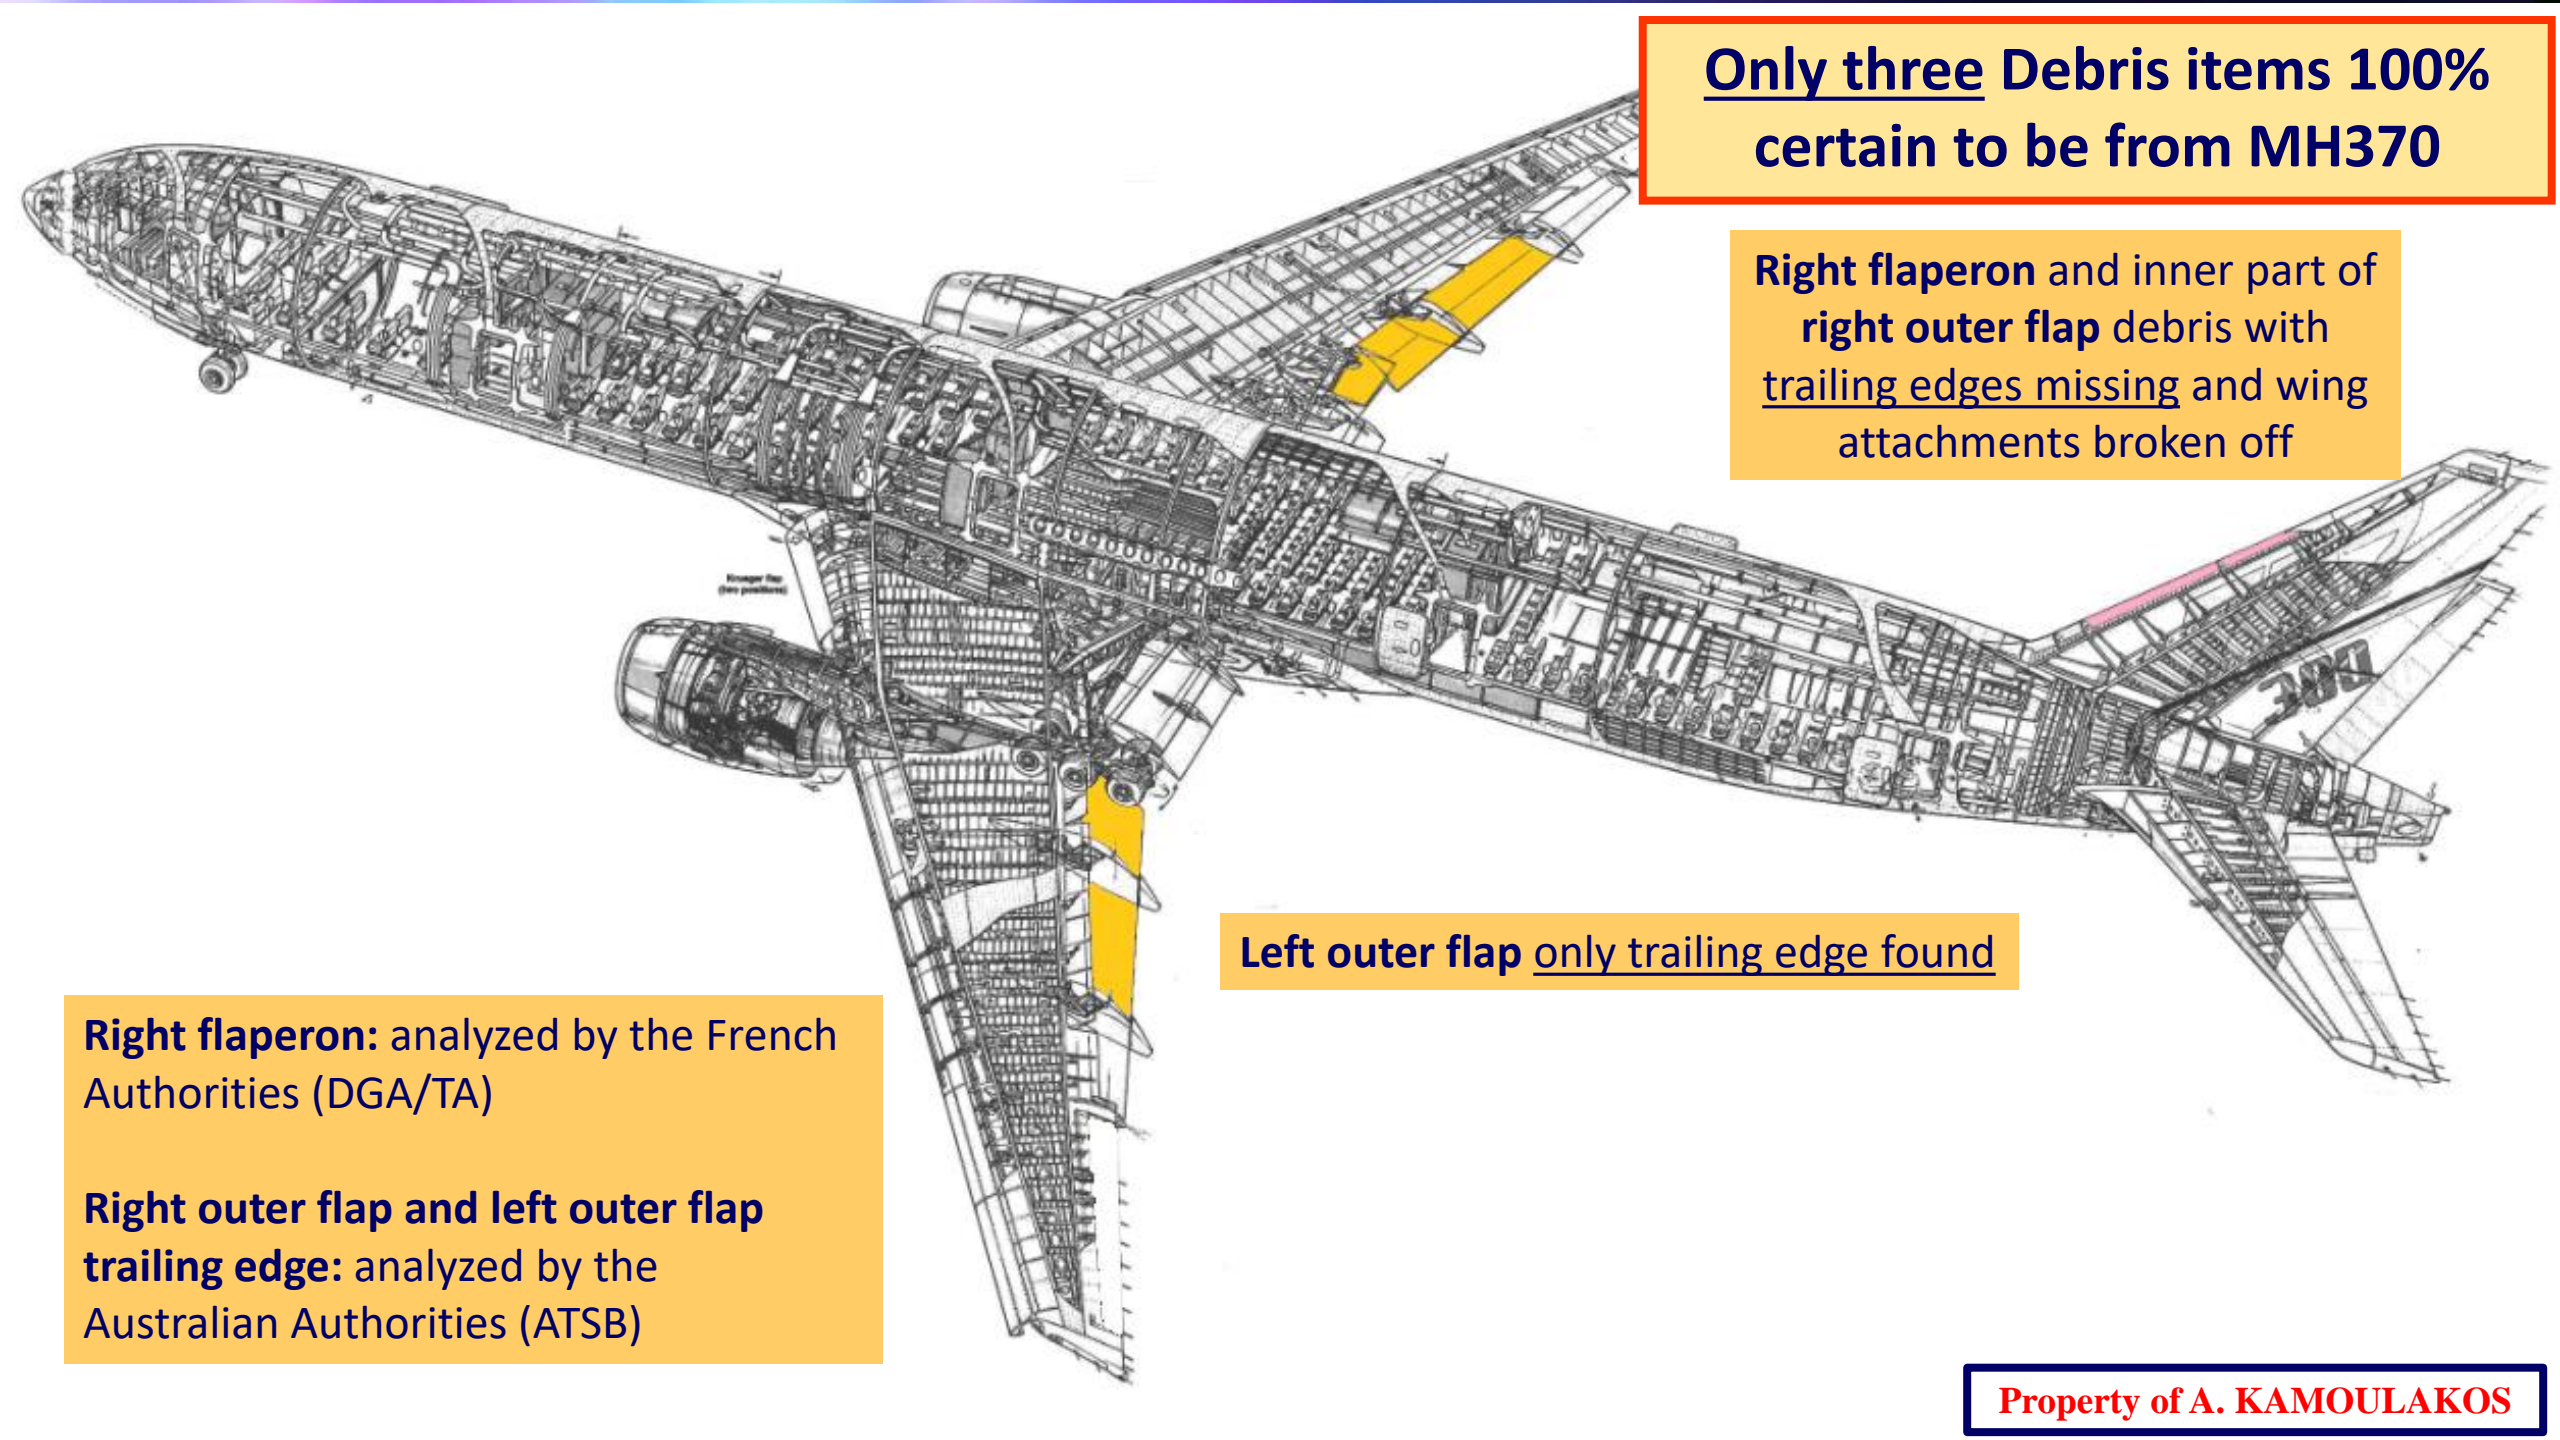
Only three Debris items 100% certain to be from MH370

Right flaperon and inner part of right outer flap debris with trailing edges missing and wing attachments broken off

Left outer flap only trailing edge found

Right flaperon: analyzed by the French Authorities (DGA/TA)

Right outer flap and left outer flap trailing edge: analyzed by the Australian Authorities (ATSB)

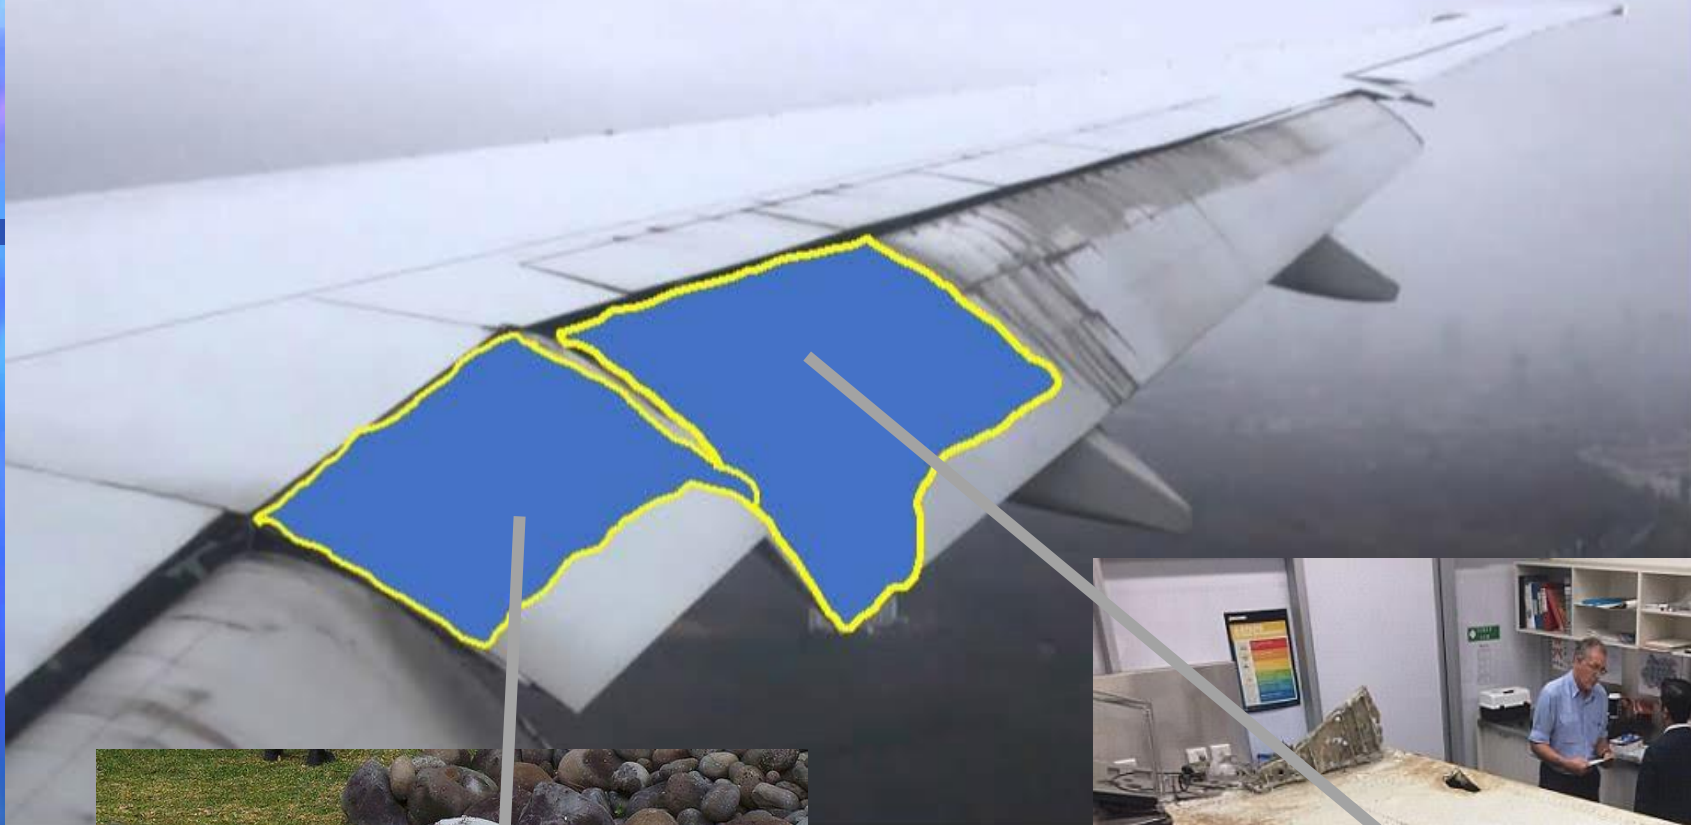
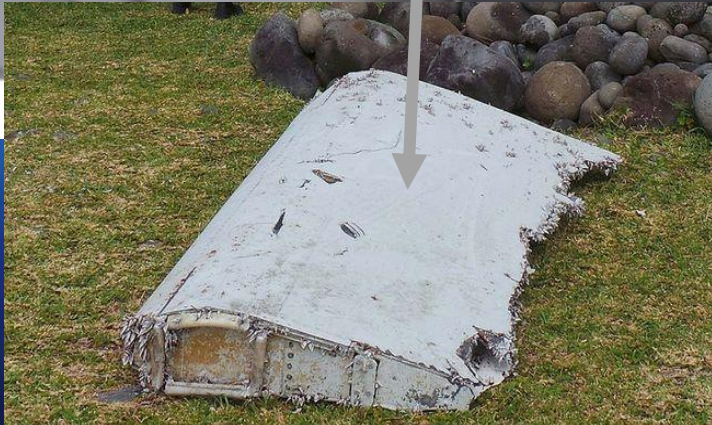
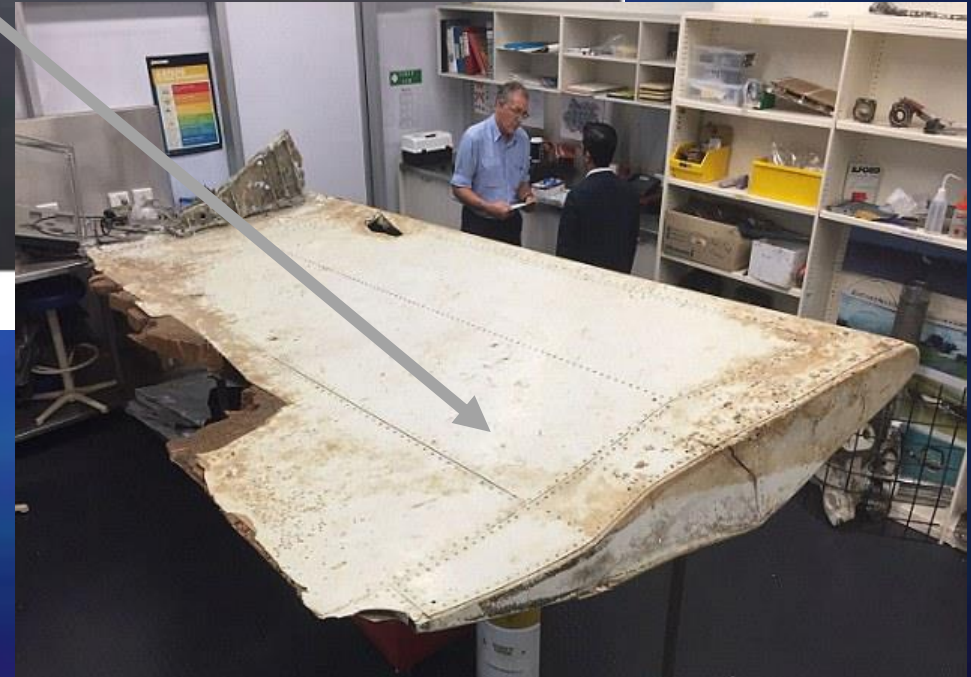
Combined location of Flaperon and Flap Debris

- Only three debris items are 100% certified to be from MH370.
 - 100% means that part serial numbers were fully identified upon them.
- These three debris items have in common the trailing edges (rear edges) been broken off.
 - **Right wing flaperon:** trailing edge missing.
 - **Inner part of right wing outer flap:** trailing edge missing: rupture shape **similitude with flaperon** (see next page).
 - OBSERVATION: the similitude can imply that they experienced similar event; if we assume water impact, then they were together when they hit the water.
 - **Left wing outer flap:** only trailing edge recovered.

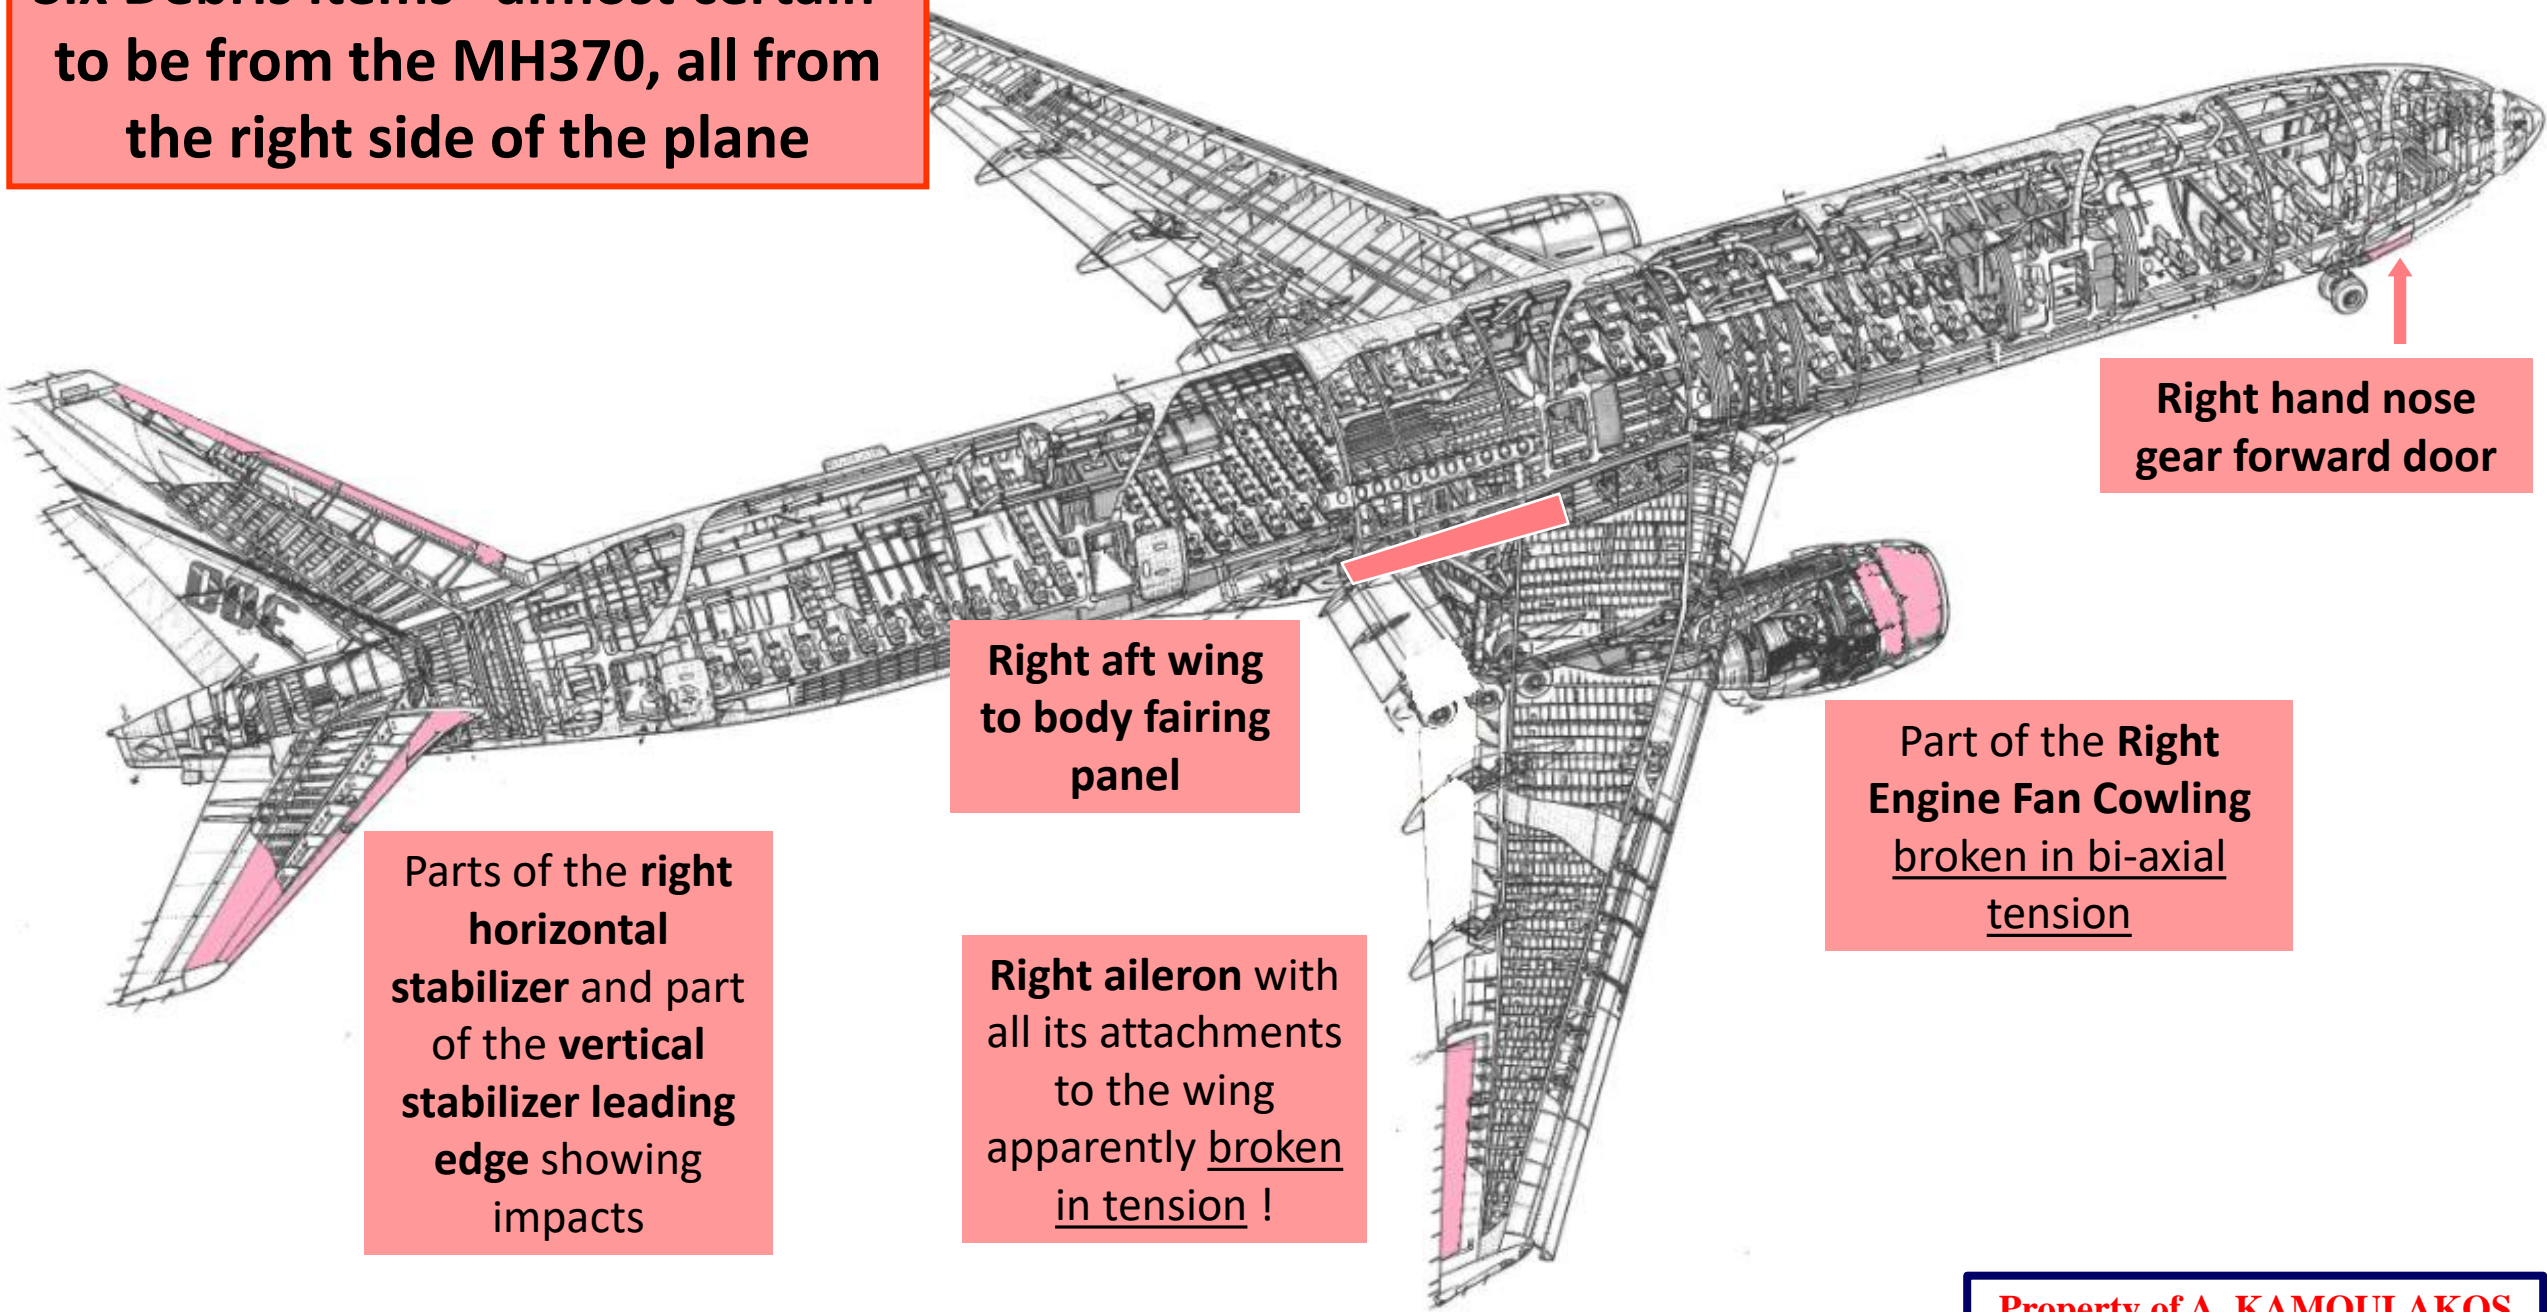
**Six Debris items “almost certain”
to be from the MH370, all from
the right side of the plane**

**Right hand nose
gear forward door**

**Right aft wing
to body fairing
panel**

**Part of the Right
Engine Fan Cowling
broken in bi-axial
tension**

**Parts of the right
horizontal
stabilizer and part
of the vertical
stabilizer leading
edge showing
impacts**

**Right aileron with
all its attachments
to the wing
apparently broken
in tension !**

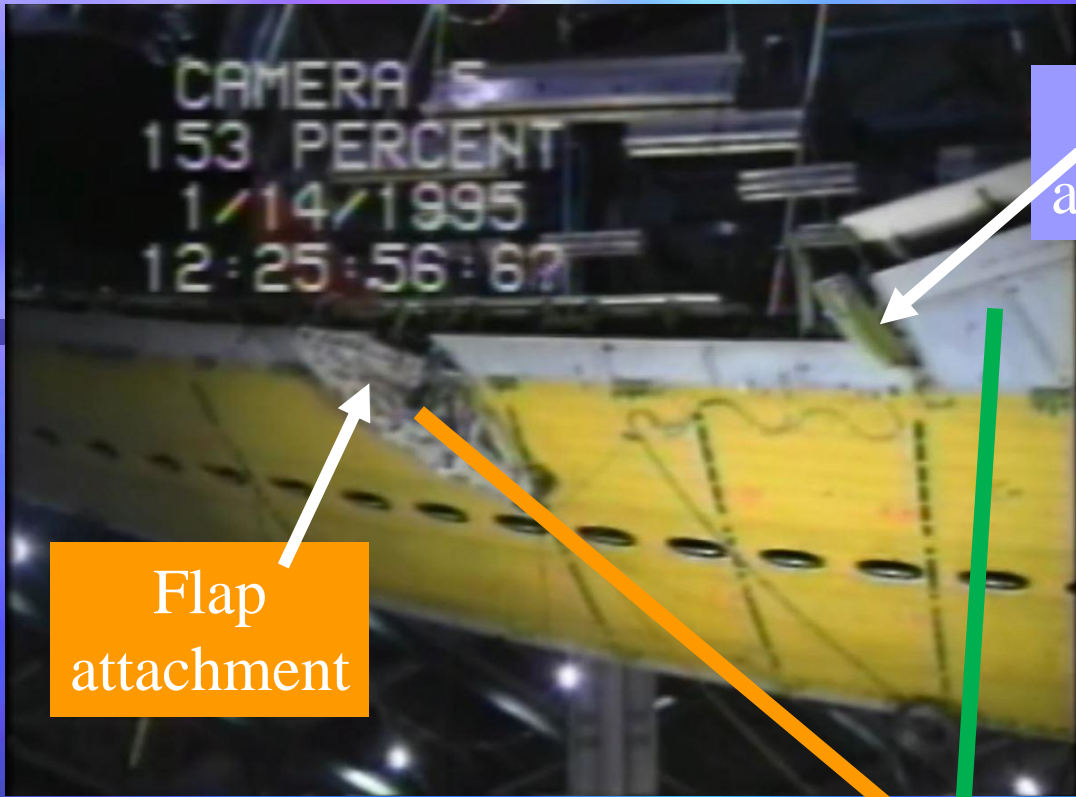
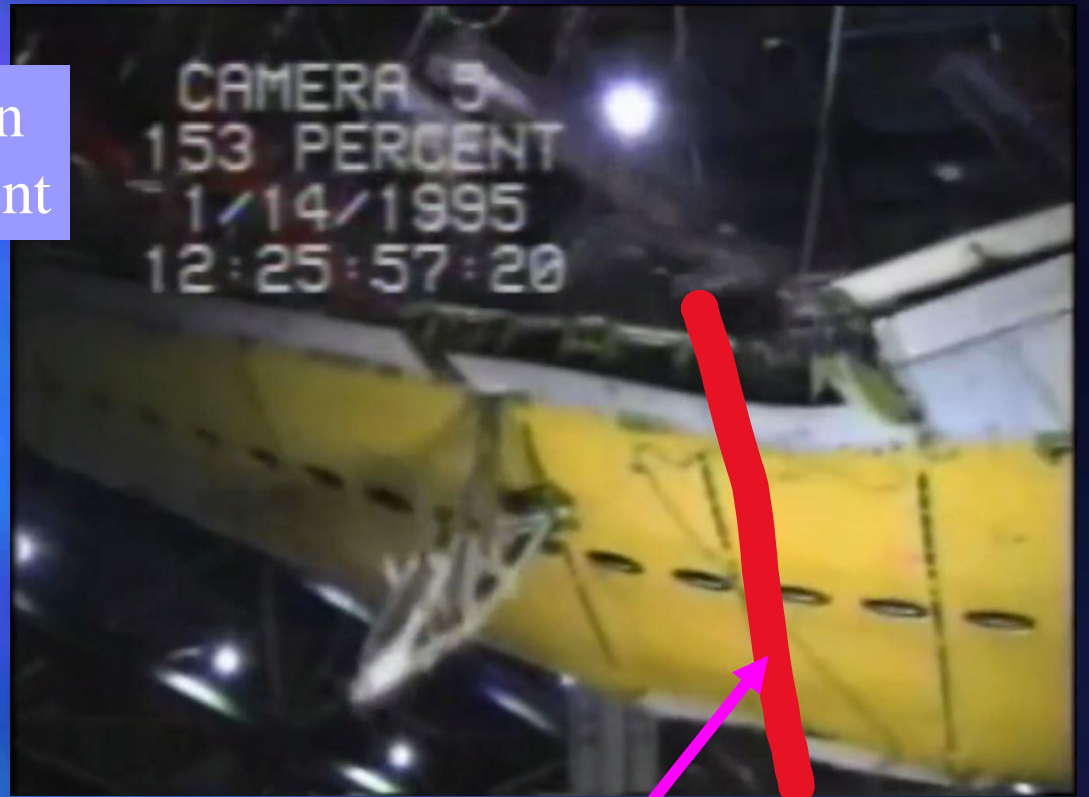
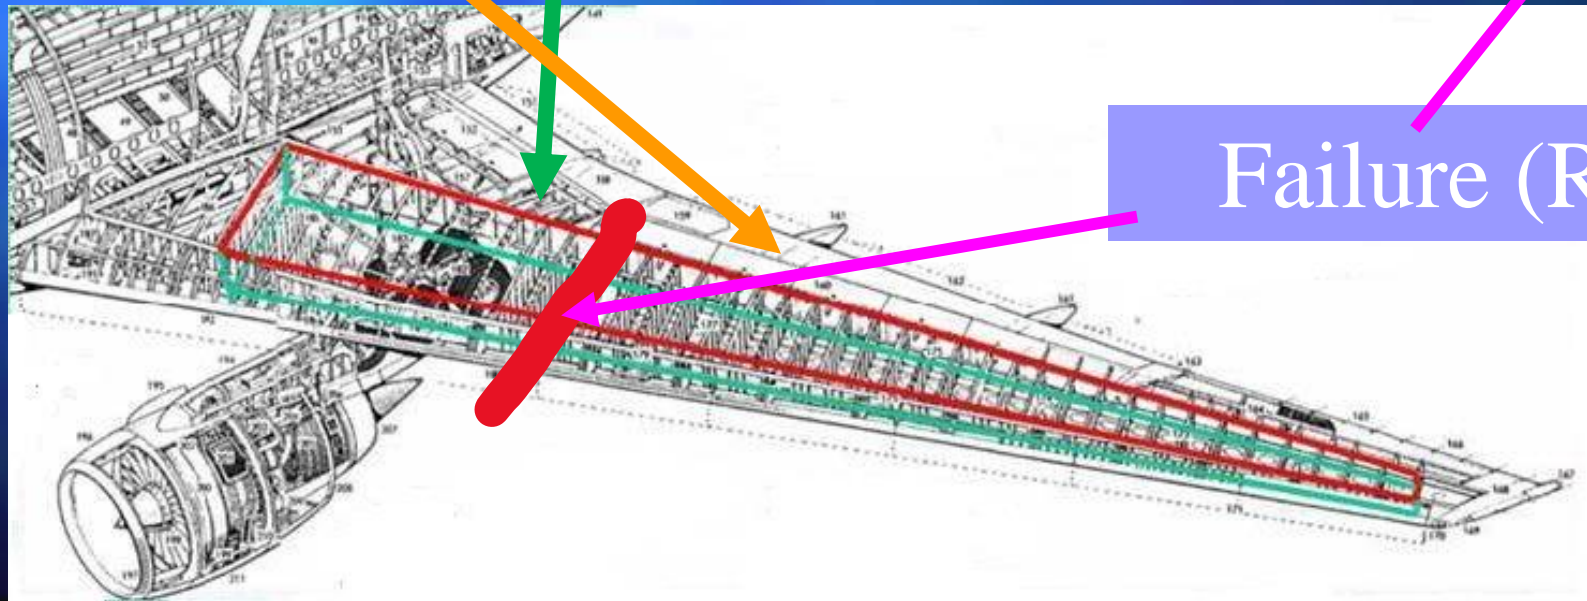
**Boeing B777
certification
test**

- “... *Wing failure occurred at 154.4% from our initial readings. Failure occurred in both wings, so again analyzing data afterwards we determined that they failed 20 milliseconds apart; **right wing going first.** Additional analysis after that showed that **the right wing failed beginning in the area of rib 25** ...”*
- *“... This test, at destruction, we failed at approximately **24 feet tip deflection of the wing** ...”*
 - This is about 7.3 meters tip deflection.
- **To our understanding, Rib 25 area appears to be in the vicinity between the inner part of the outer flap and the right engine support pylon, close to the flaperon. Look image from the certification test in next page.**

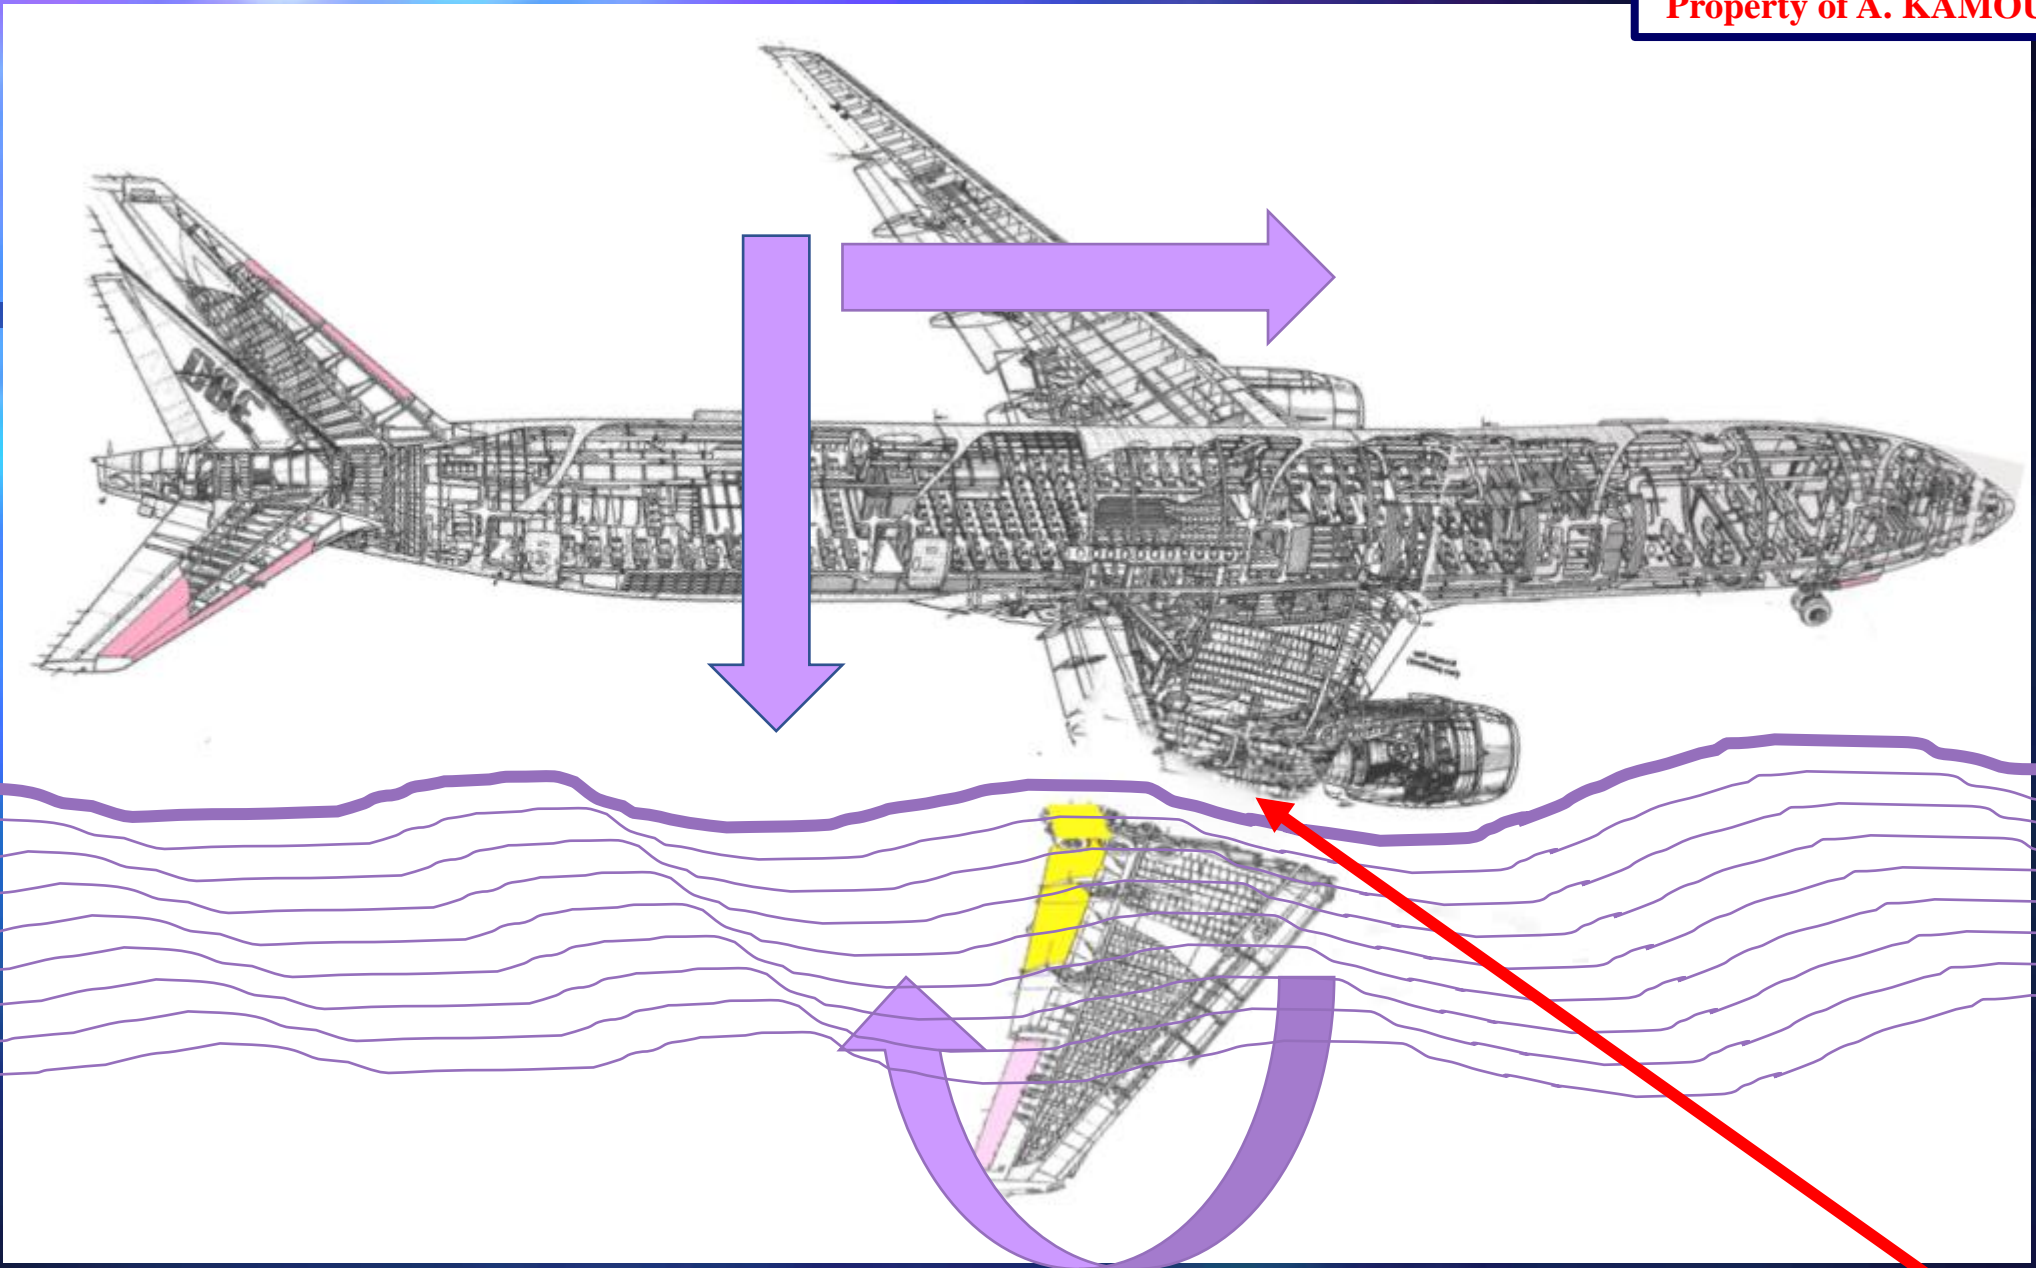
Violent wing first-impact with extreme upward bending leading to failure in Rib 25 area

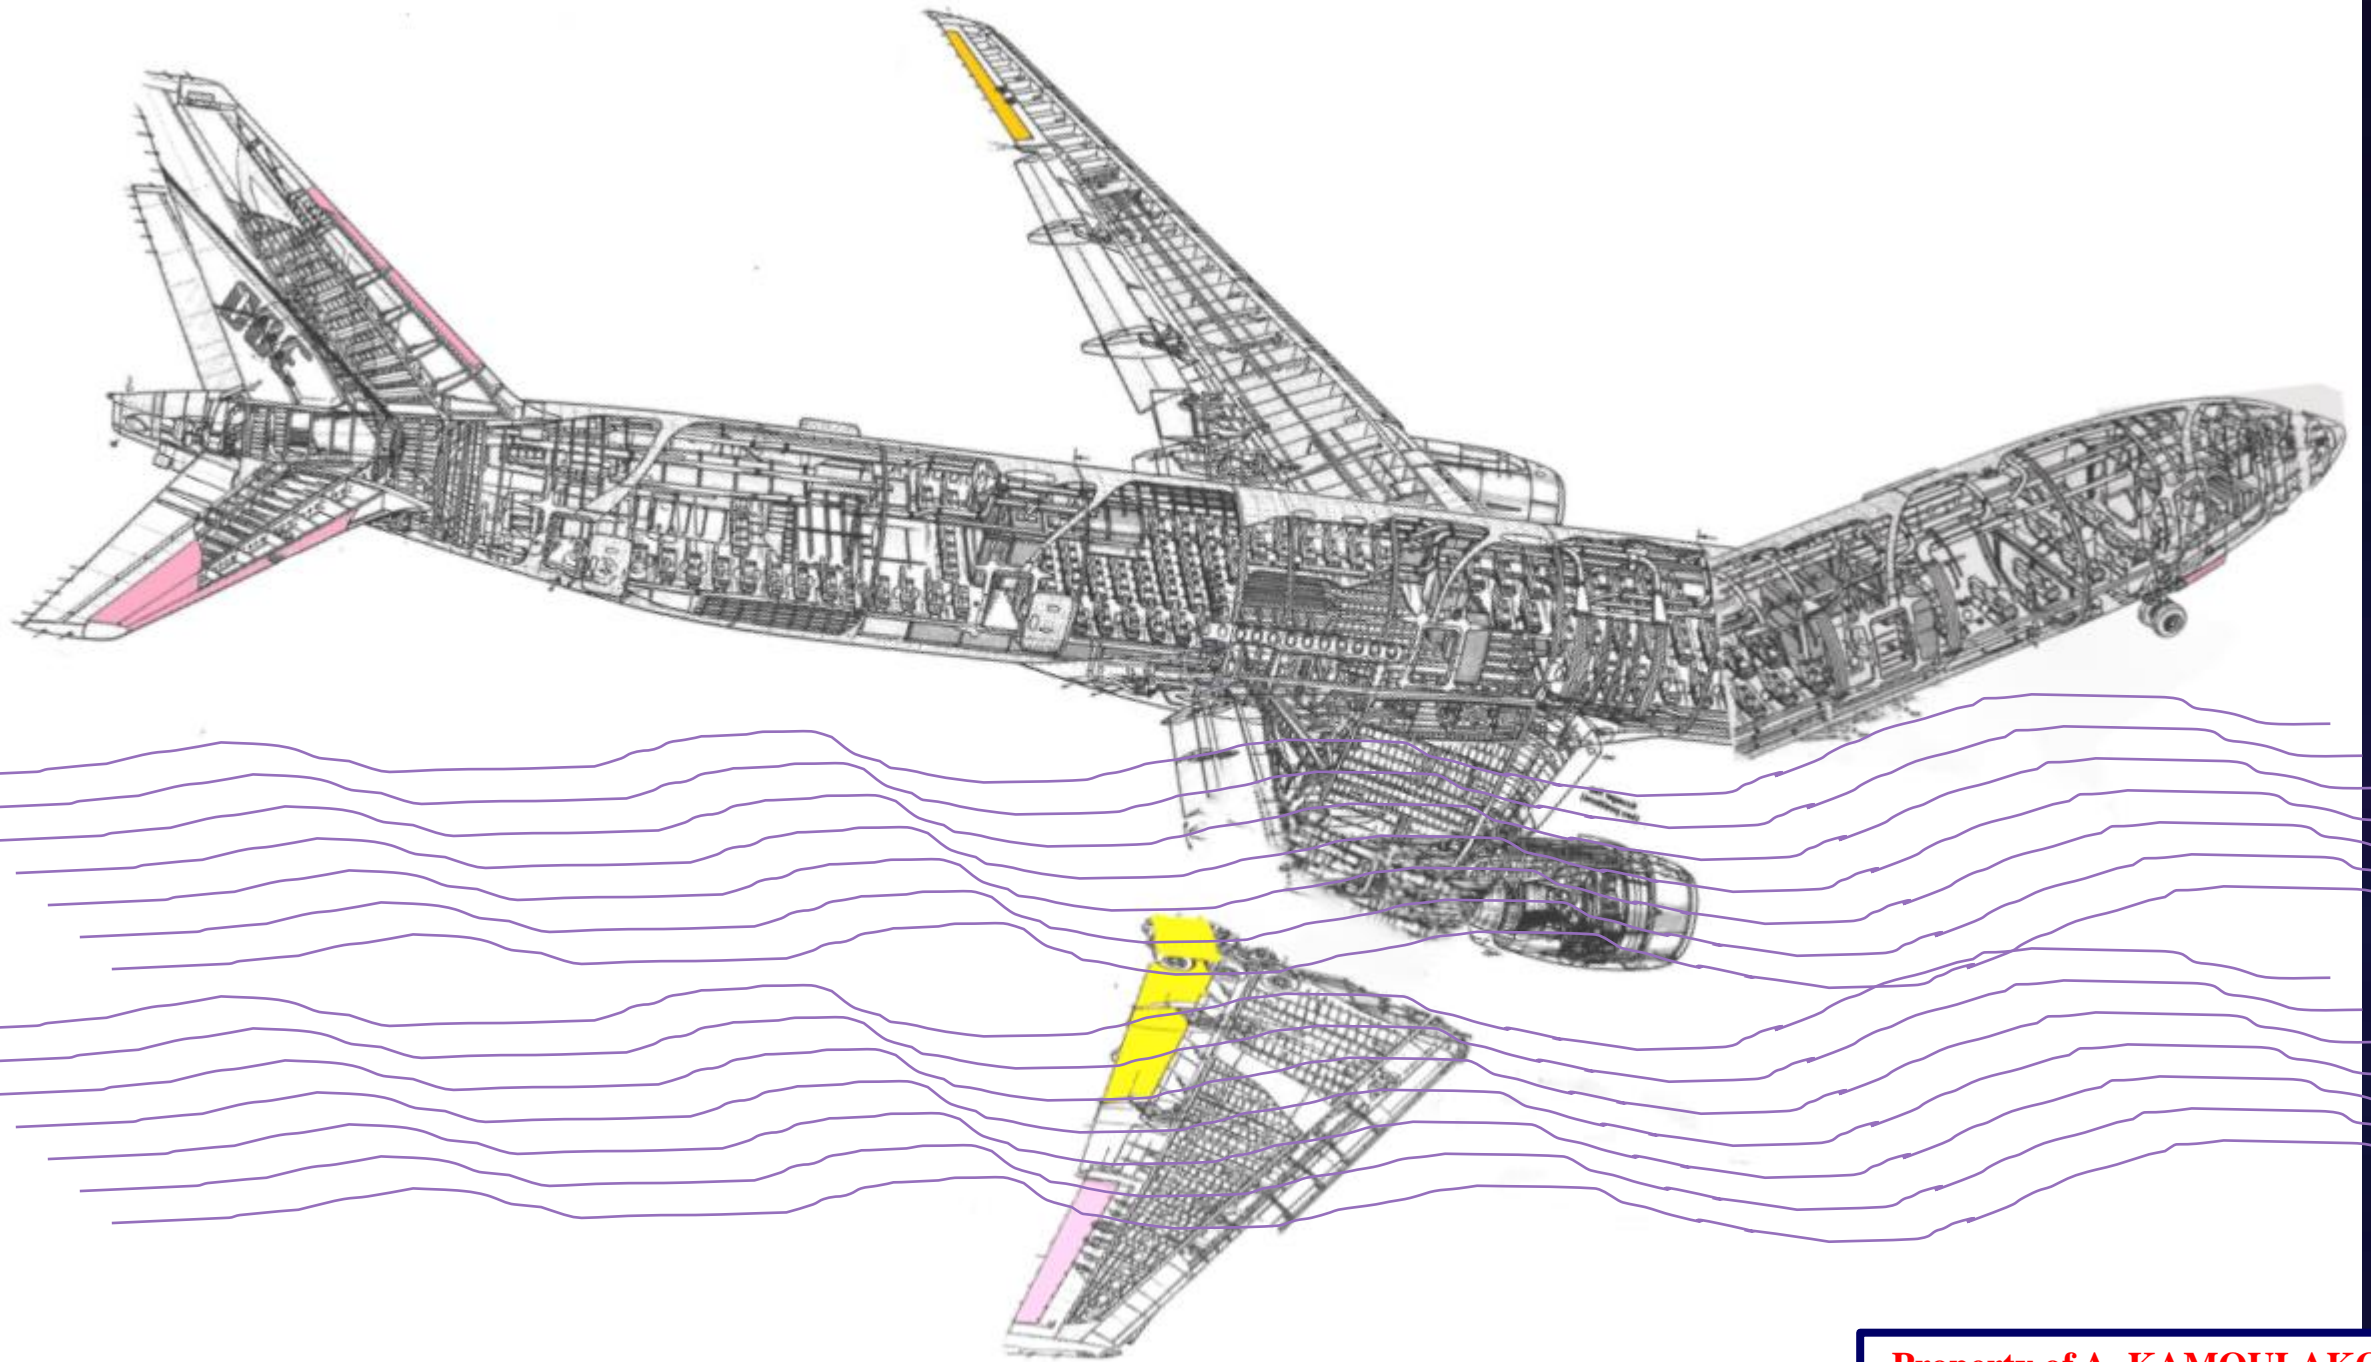
Yaw rotation and impact of the aircraft “nose”

- It follows a **large aircraft yaw to the right** (pivoting around the deforming right wing) and **impact of the aircraft frontal fuselage underbelly** releasing **(at least)** the right-hand nose gear forward door .
- **damage of the frontal part of the fuselage/cabin** that might lead to rupture at the level of the attachment to the “central wingbox” (junction between wing and fuselage).

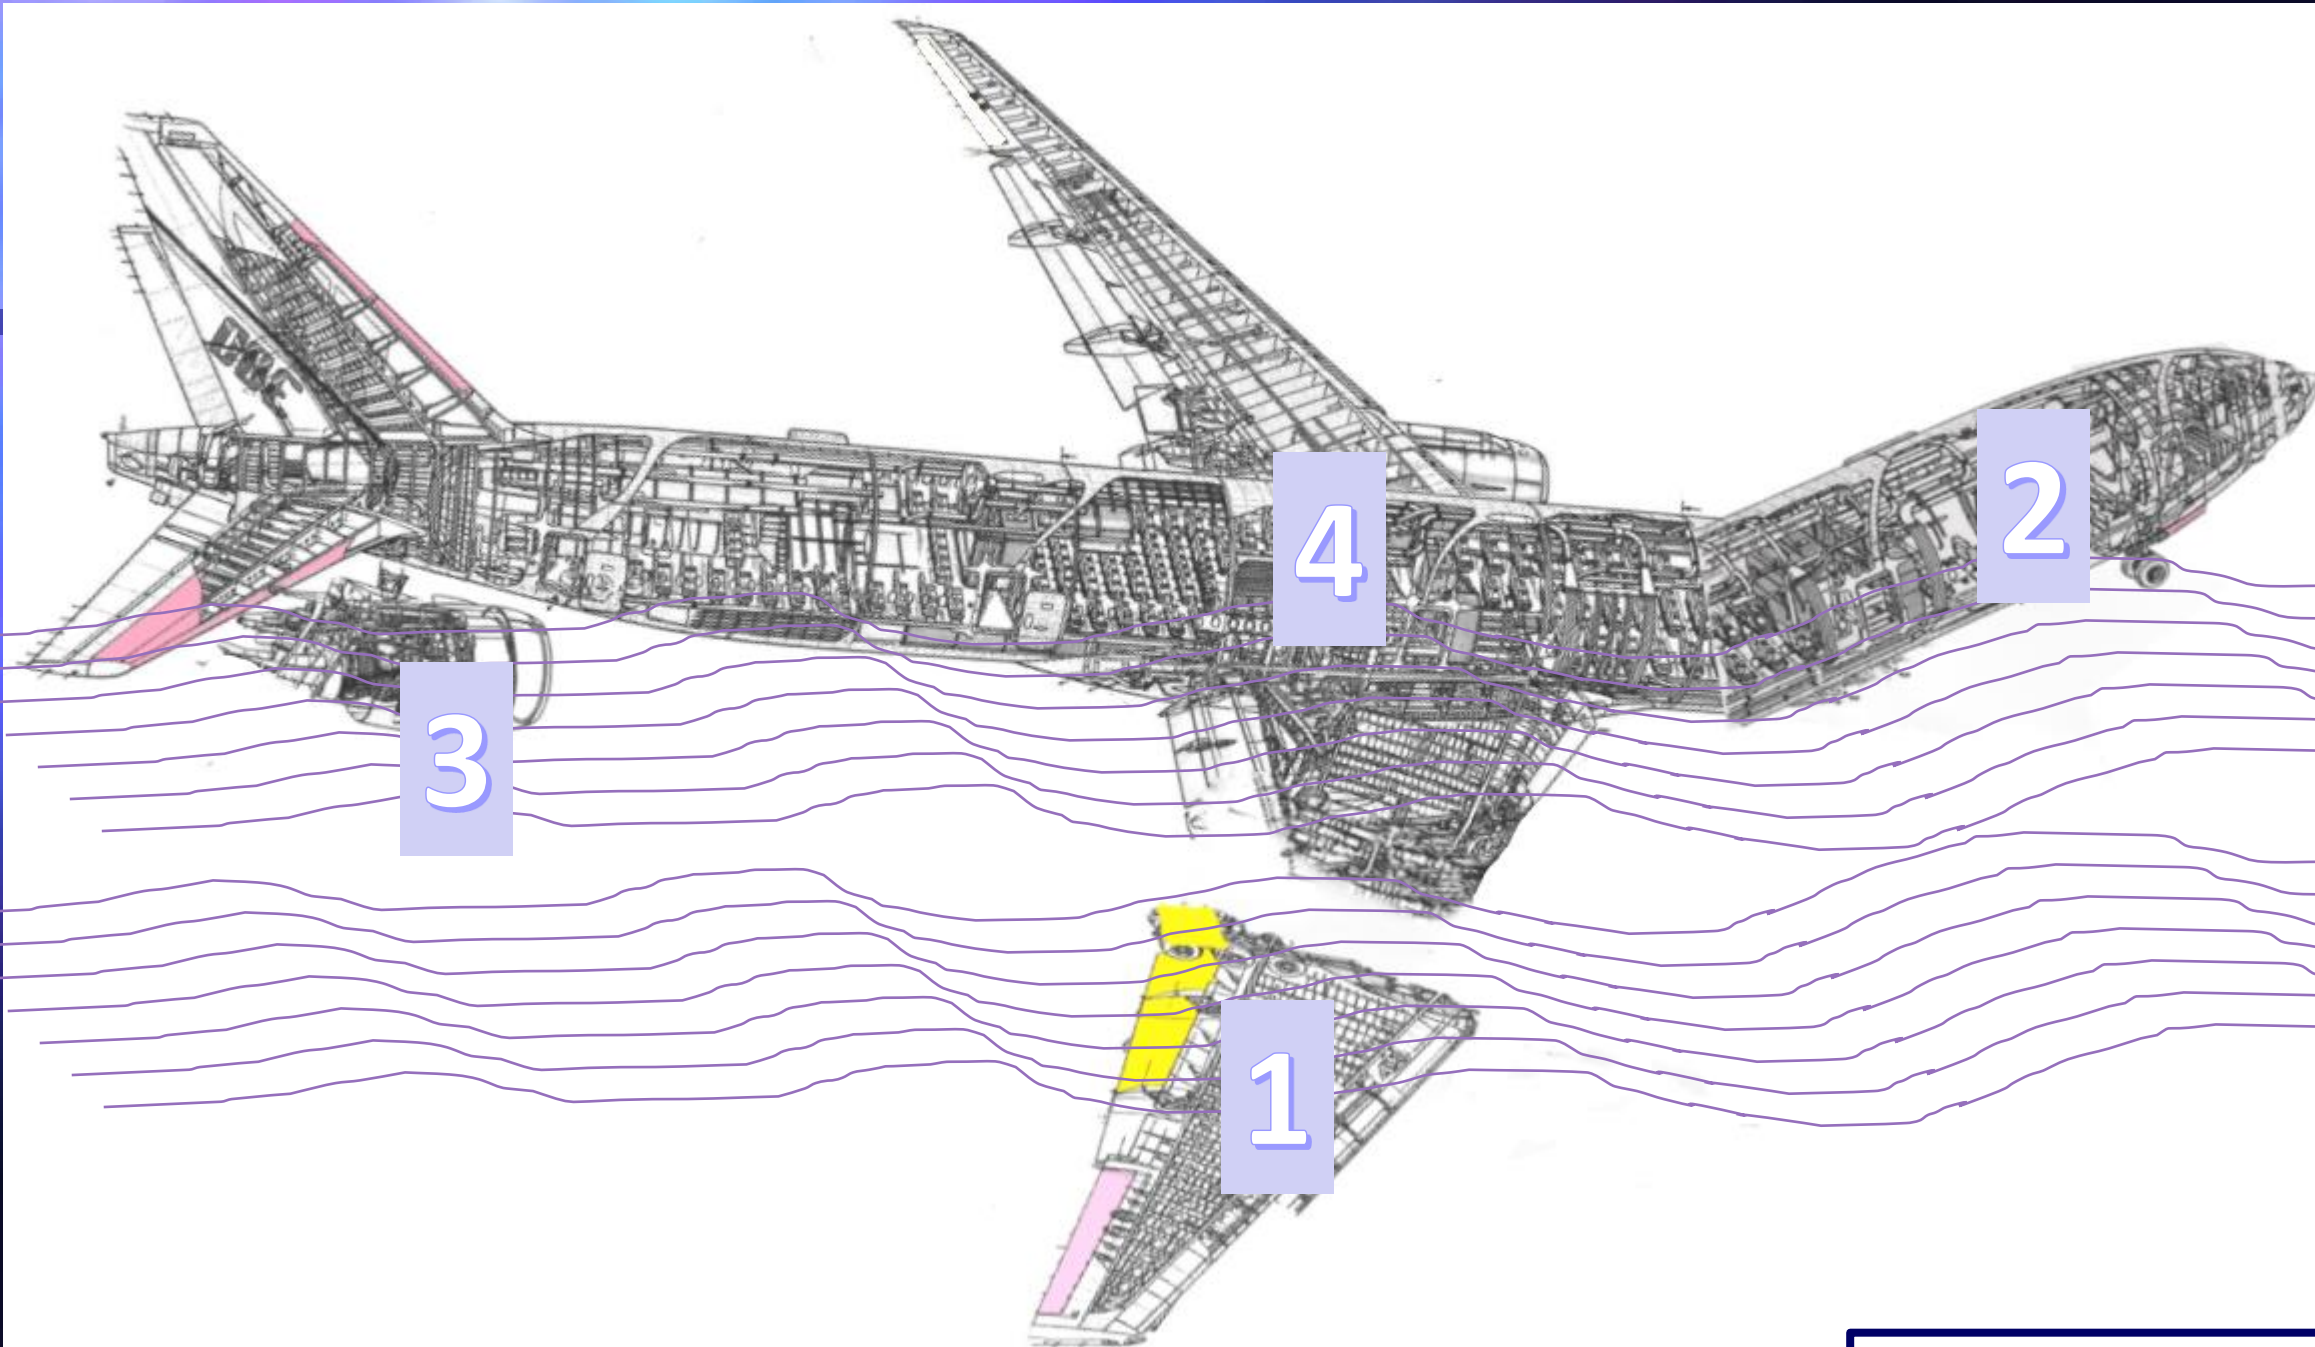
Aftermath ...

- Finally the **main aircraft wreckage** could consist of four parts:
 1. The right wing part after the engine pylon (Rib 25 area) outwards.
 2. The front part of the fuselage heavily damaged or detached.
 3. The right engine.
 4. The central fuselage with the root of the right wing and the entire left wing plus maybe the left engine and maybe the rear fuselage with the tailfin and right stabilizer heavily damaged, all as one piece.
