An assessment of the last seconds of the MH370

Argiris Kamoulakos

08 March 2024

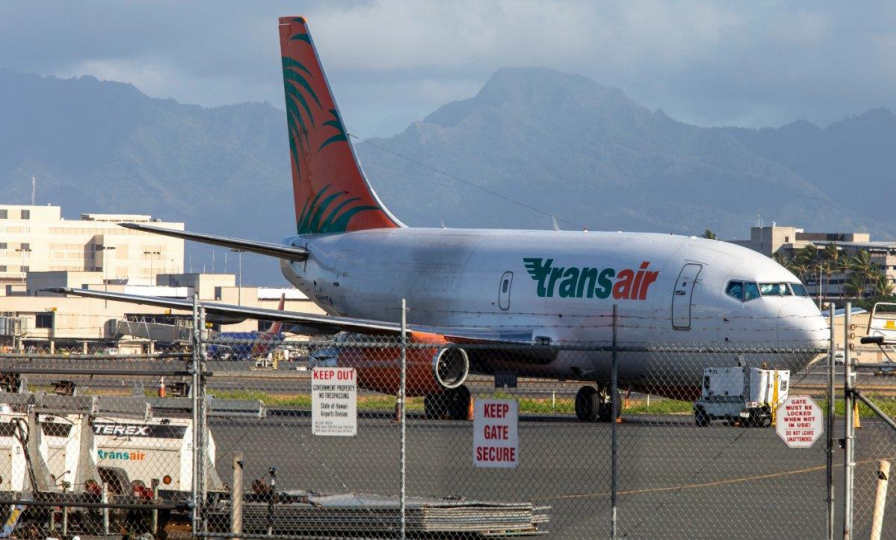
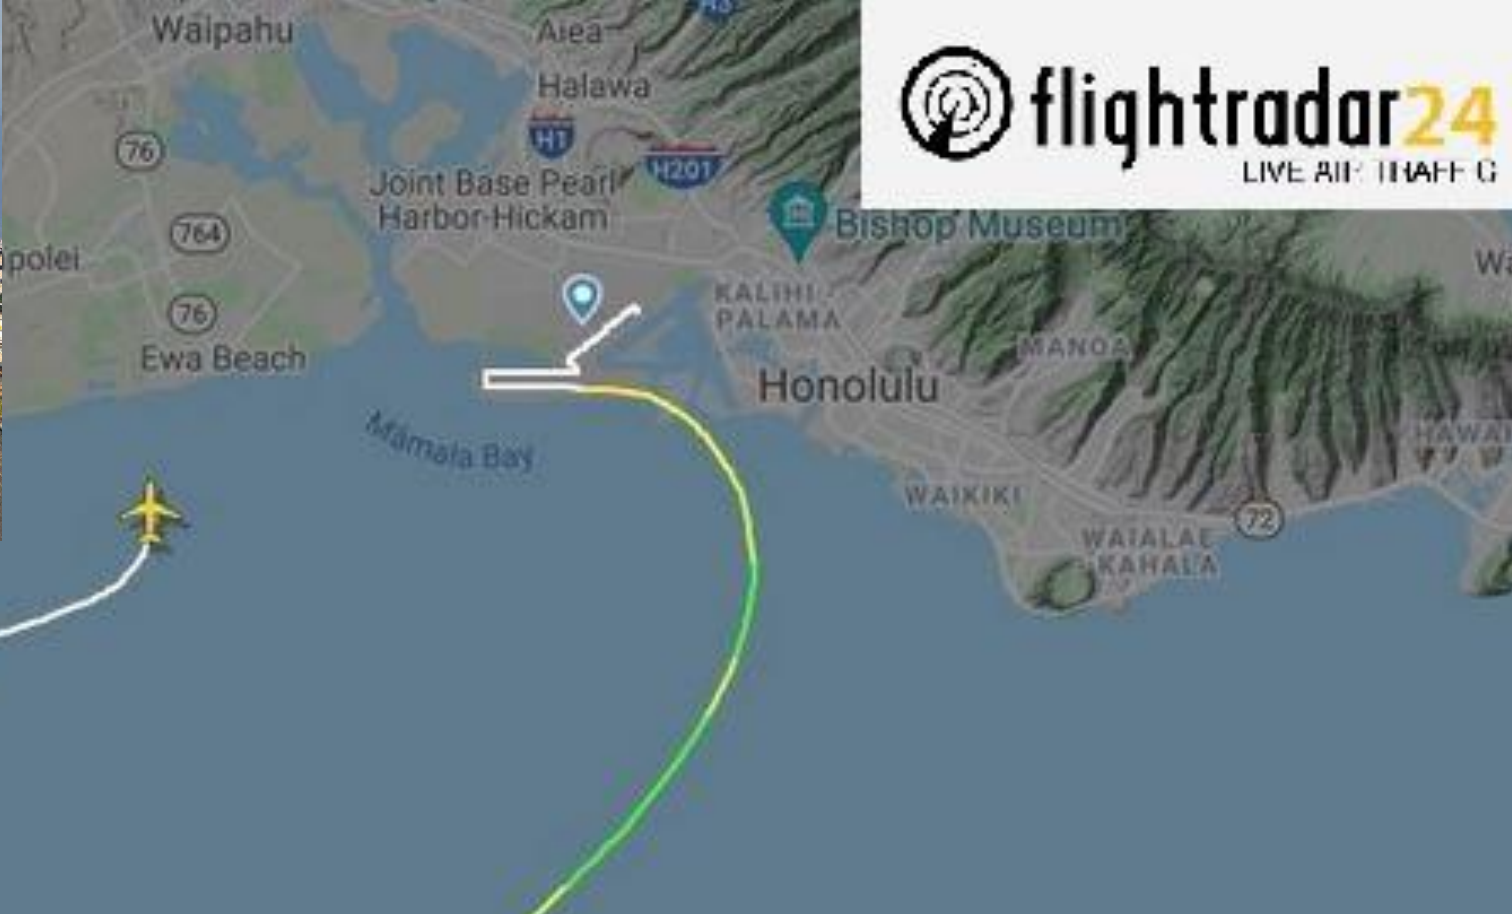
Transair Flight 810 Boeing 737-200 Cargo crashed to the sea shortly after takeoff in the early morning of July 2, 2021.

Air-ground communications indicate that the aircraft was suffering engine failure, and unable to hold altitude as the crew attempted to return to Honolulu. Both pilots were injured but survived the accident. The aircraft was badly damaged and sank, although a “small amount” of floating debris has been retrieved.

Aircraft broken in 3 parts

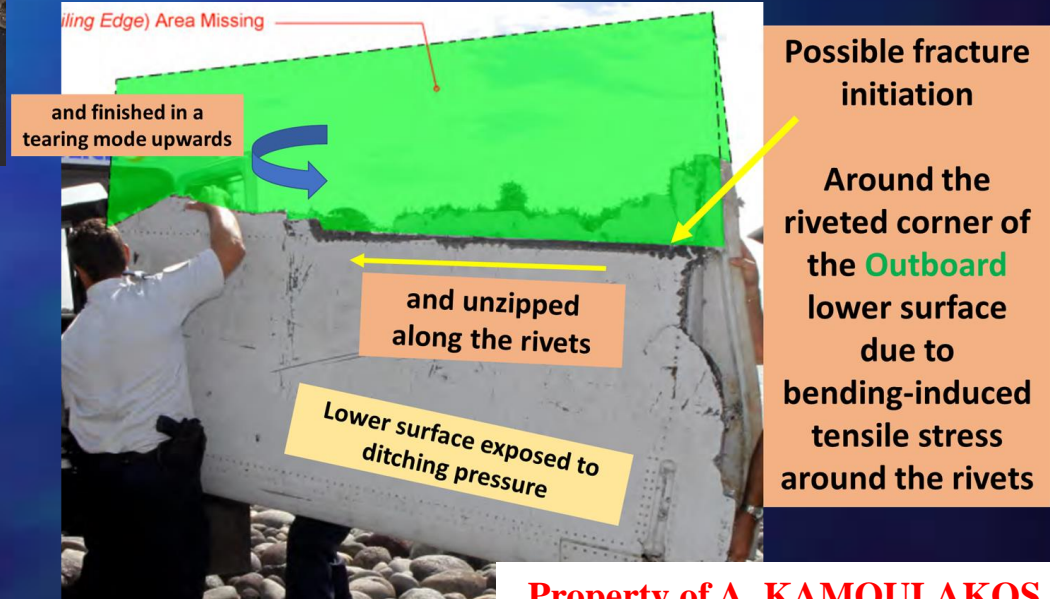
- Each of these curves corresponds to a particular flaperon inclination to the sea surface, which might mean many different configurations. For instance flaperon at 30 degrees might mean:
 - sea-surface calm, wing horizontal, flaperon extended at 30 degrees
 - sea-surface calm, wing at 15 degrees, flaperon extended at 15 degrees
 - sea-surface disturbed with ascending wave crest of 15 degrees, wing at 15 degrees and flaperon extended at 30 degrees, etc.
