# Debris Analysis

## Article recovered at Jeffreys Bay, SA.

Mike Exner and Don Thompson

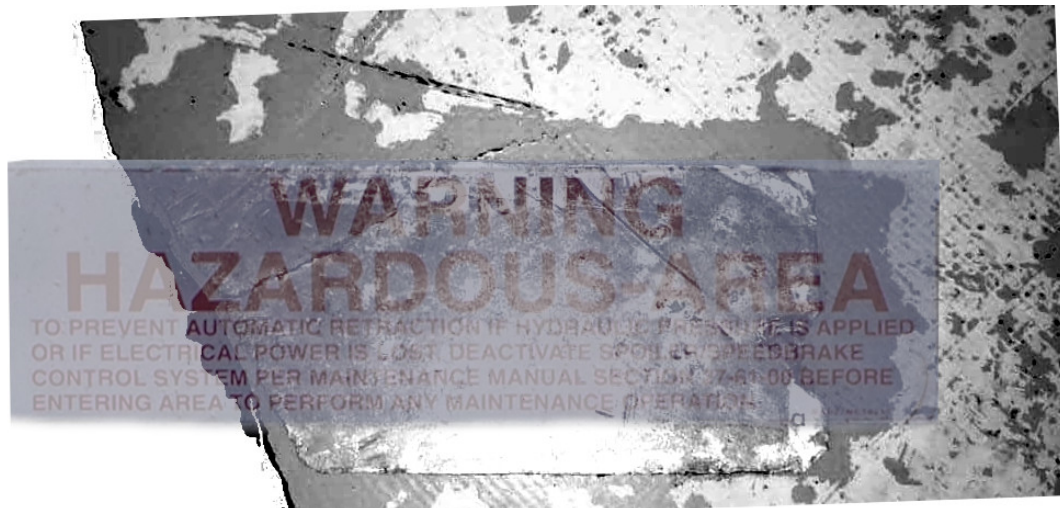
Figure 4: Safety Information Placard, B777 Spoilers

This placard text refers to ATA Chapter 27-61-00, that is ‘Spoiler and Speed-brake Control’.

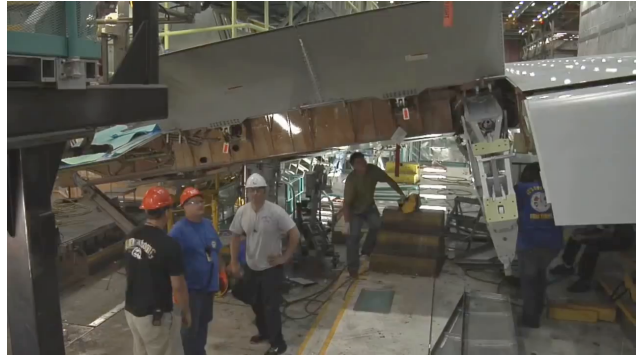
Inboard spoilers #8 and #9, right wing

However, with only the photographic images at hand, it is not possible to discriminate the recovered article as either spoiler #8 or #9.

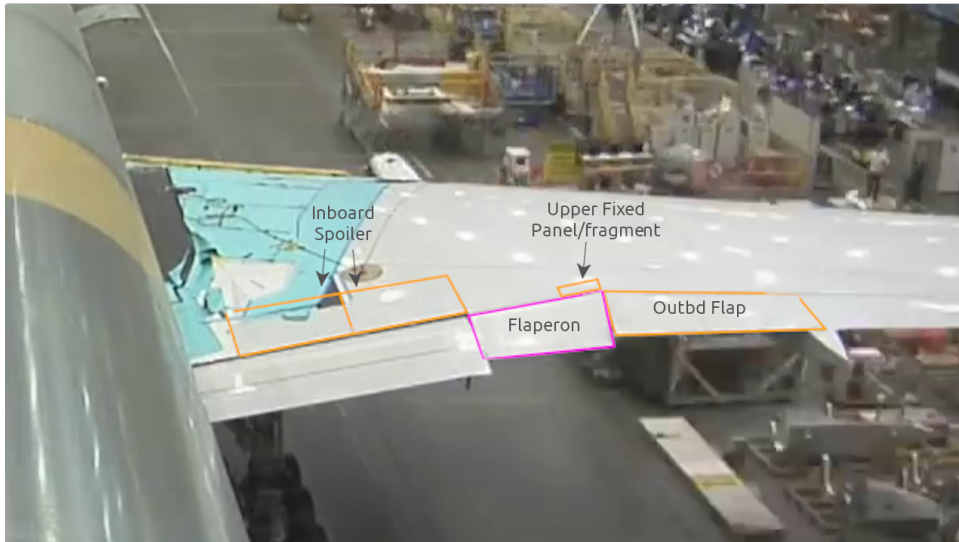
Figure 9: Original positions: inboard spoilers, flaperon, outboard flap, upper panel

The recovered article was fixed to the right wing in the area between the wing-fuselage join and the flaperon, located immediately forward of the inboard flap, as illustrated in Figure 9

The inboard spoiler, flap and flaperon each separated from the mounting attachments fixing the structures to the rear spar of the right wing. The damage exhibited by these three structures is consistent with a span-wise, destructive, flex of the right wing. It is feasible that subsequent to fuel exhaustion, an uncontrolled

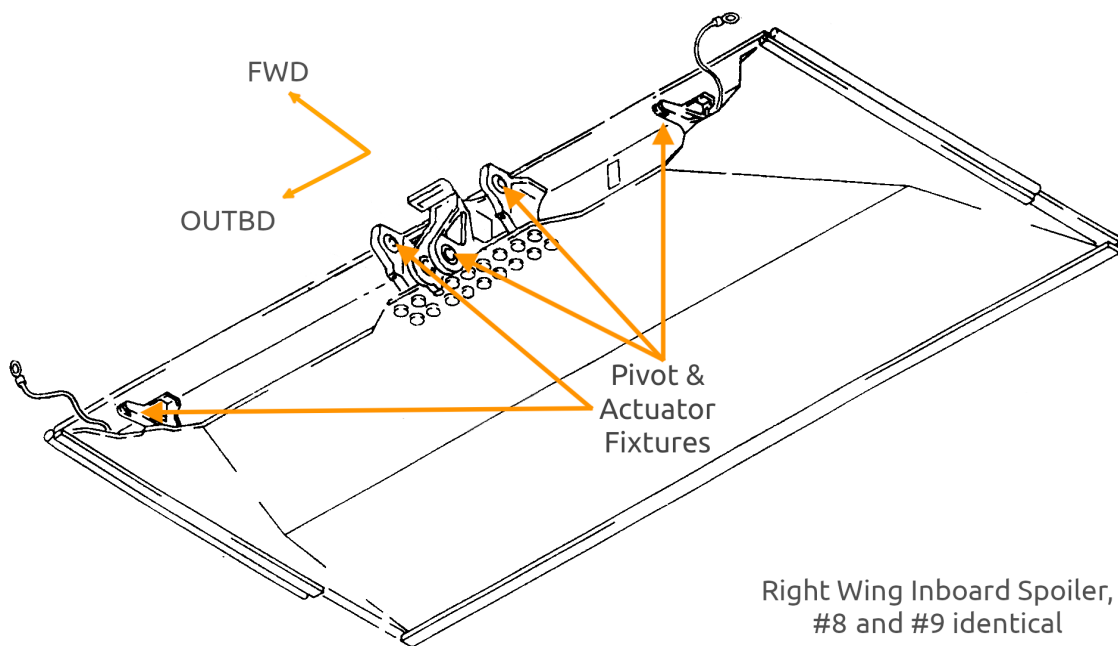
Figure 10: Line drawing, RH Inboard Spoiler

The inboard spoiler attaches to the wing rear spar at five points along its forward face: with a pivot link at each end of the face (A)-(D), an additional pivot link at each side of the actuator fitment, and the actuator itself as illustrated in the line drawing at Figure 10
